**Service Action: Remove Front Bumper Air Inlet Panel**

F30 (3 Series Sedan)

Produced from June 26, 2014 to July 4, 2014

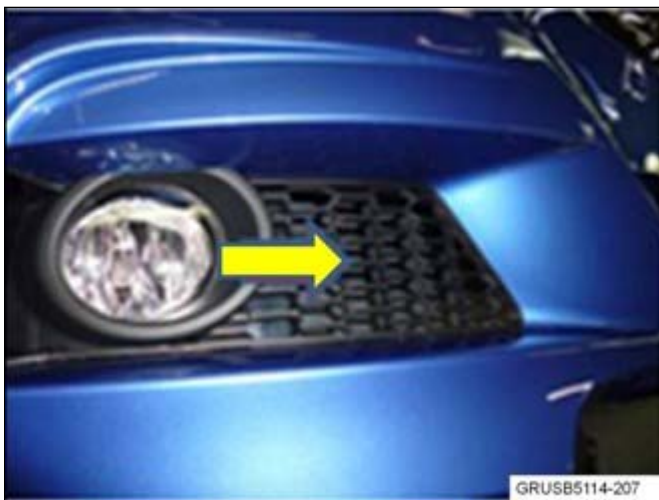
1. The sealing panel is located on the right side of the front bumper, behind the air cooling intake grill.

Remove the sealing panel in the air cooling intake duct and discard.
