Service Action: Install Missing CAN Terminating Resistor

F82 (M4 Coupe)

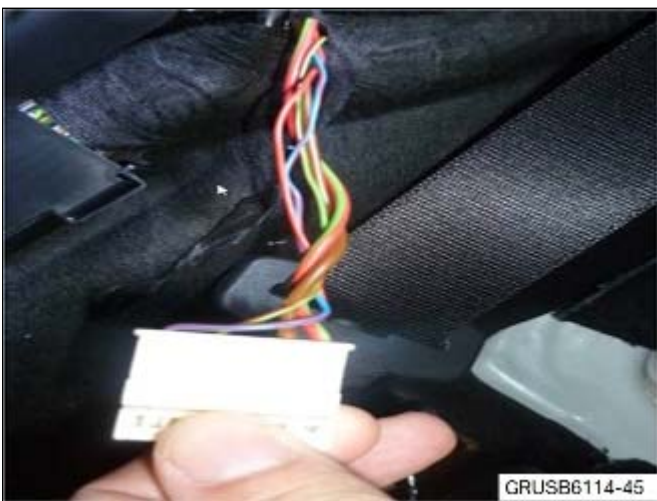
The CAN (Controller Area Network) terminating resistor is missing from the vehicle wiring harness near the EKPS (Electric Fuel Pump Control) module.

5. Expose and untwist the wiring harness and identify the two CAN wires:

Pin 9 – Blue/Red

Pin 16 – Red
