Service Action: Check and Repair the NVLD Wiring Harness

F83 (M4 Convertible)

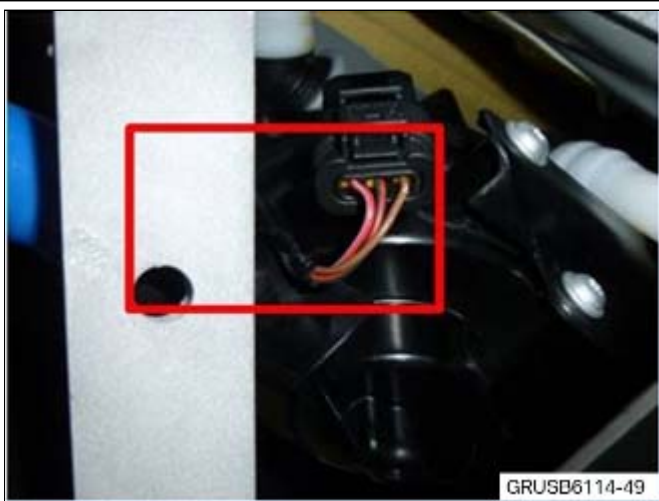
The wiring harness for the NVLD2 (Natural Vacuum Leak Detection: tank leak diagnosis) may rest against the right rear strengthening brace and chafe through the harness insulation. This may lead to a short circuit and blow Fuse 104.

5. Check the wiring for damage in the area of the brace, as shown.
6. If the wiring is damaged, repair as needed based on ISTA Repair Instruction 61 13... "Treating cables and optical fibres," (recommendations for repairing cables).
7. Ensure that Fuse 104 is not blown and replace as needed.
