SUBJECT

Top Rear Side View Camera Control Unit Rattles While Driving

F30 (3 Series Sedan)

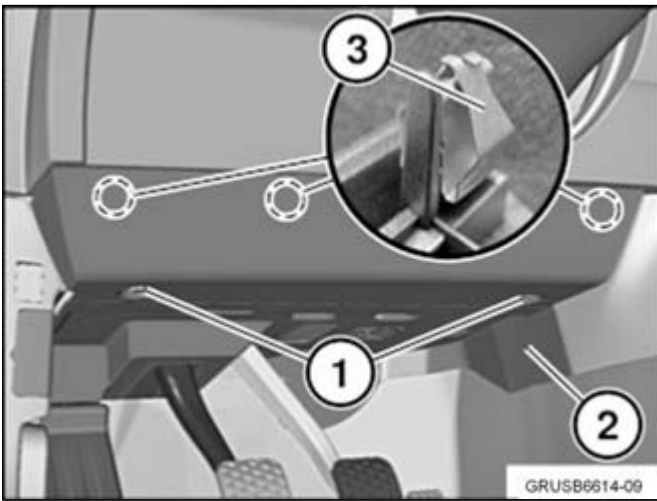
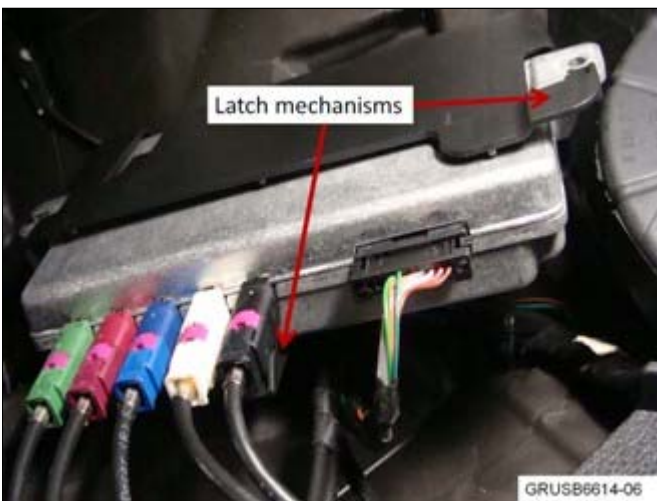
| | <ol style="list-style-type: none"> 2. Access the camera control module by removing the "Trim panel for pedal mechanism" per REP 51 45 184. 3. Unscrew the two nuts (1). 4. Release the trim panel (2) at the clamps (3). 5. Slightly lower the trim panel (2) and disconnect the plug connections for the light and the speaker. |

Installation Note: The tightening torque for the nuts (1) is 4.6 Nm.

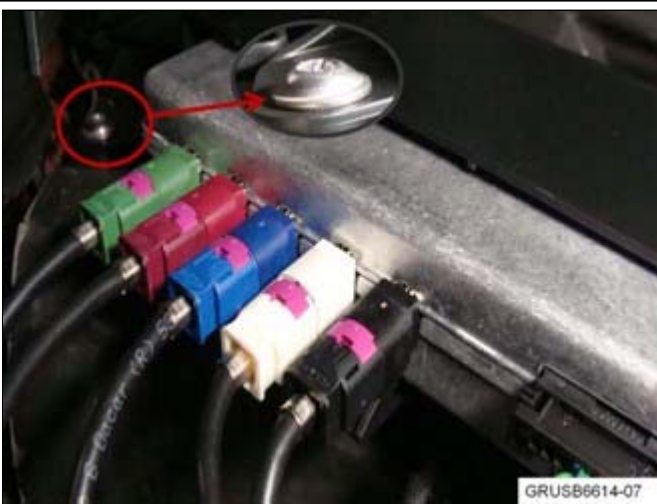
6. Locate the camera module mounted up against the A-pillar, as shown in the picture.
7. Remove the camera control module per Repair Instruction 66 53 170, "Removing and installing control unit for TRSVC," which is also included in this SI.
8. Unlock all plug connections and disconnect.
9. Unlock the latch mechanisms.
10. Remove the control module from the holder.

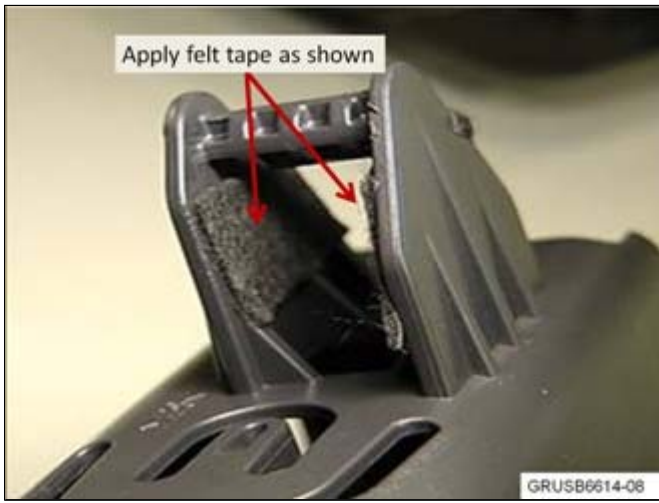
The TRSVC (Top Rear Side View Camera) control module support bracket is loose.

11. Release the screw highlighted.
12. Remove the camera control module support bracket.
