This Service Information bulletin supersedes SI M64 01 14 **dated May 2014**.

Automatic Deactivation of Recirculation Mode

MODEL

With option 0534 (automatic air conditioning)

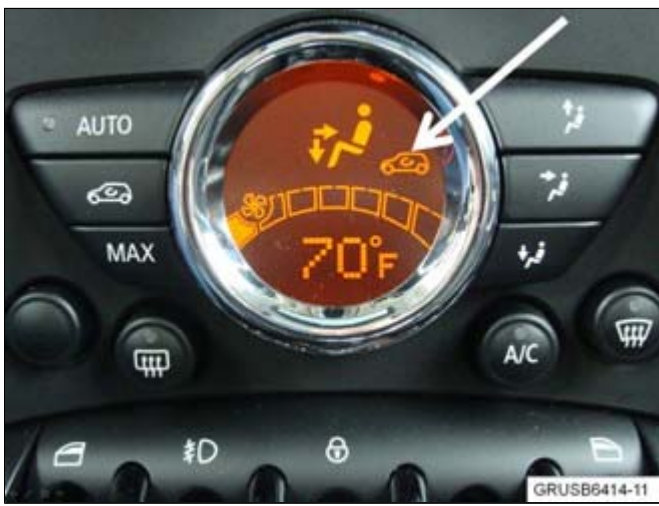
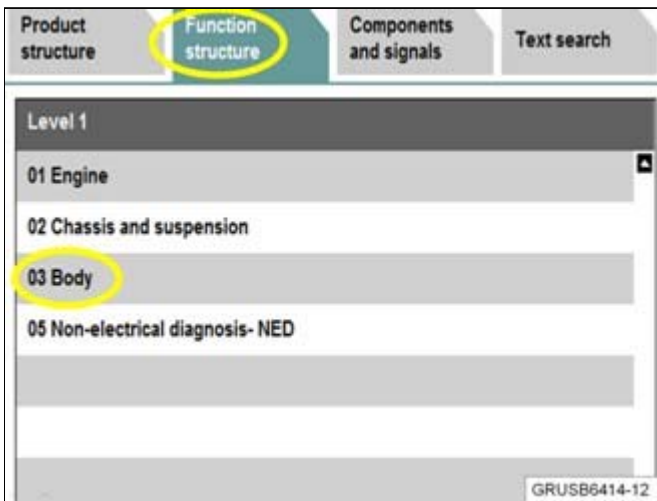
1. The recirculation display is shown when the recirculation button is pushed. It will automatically switch recirculation off after a few minutes, depending on interior and exterior temperatures, to allow fresh air to enter the cabin. This feature was added to reduce the amount of condensation and fogging on the inside of the

windows.

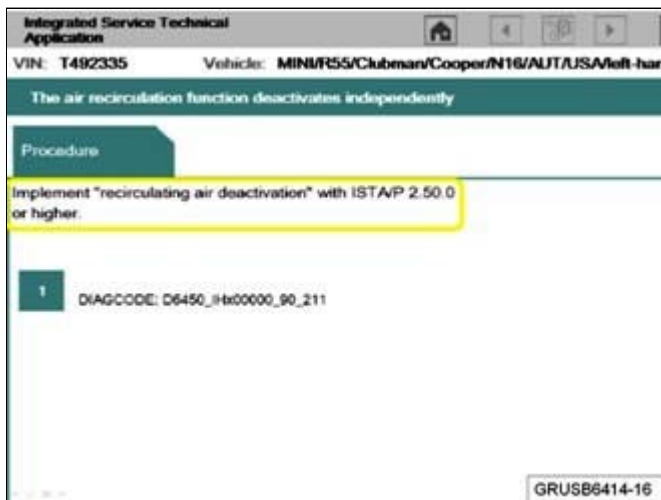
5. Select "The air recirculation function deactivates independently."

6. To remove this feature, program "recirculating air deactivation" with ISTA/P 2.52.1 or higher.
