Service Action: Inspect Front Driveshaft

E70 (X5)

E71 (X6)

E72 (X6 ActiveHybrid)

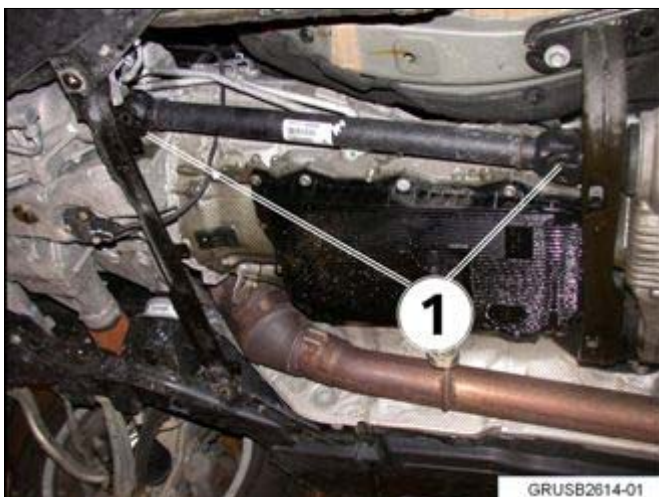
NEW Check the universal joints in the front driveshaft for radial play (1).
Note: The E72 will need to have the reinforcement plate removed to check the driveshaft U-joints. Refer to Repair Instruction 31 10 010, "Removing and installing/replacing reinforcement plate."

The driveshaft will need to be replaced if any play is found in the U-joints. Refer to Repair Instruction 26 20 000, "Removing and installing front propeller shaft as of 4/2010."

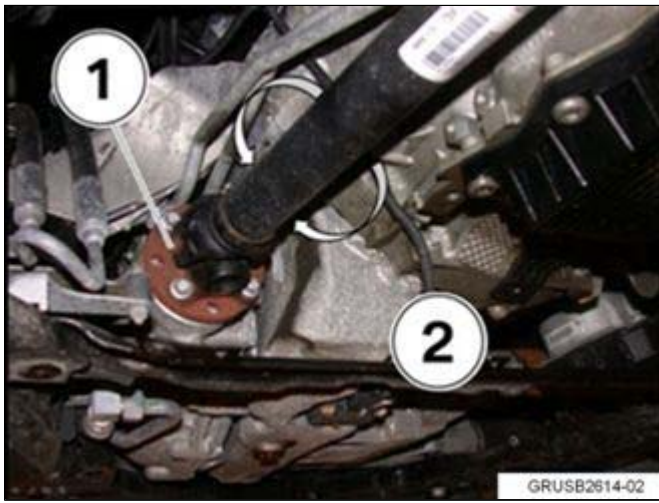
1. Checking the Front U-joint:
Hold the input flange (1) on the front differential and check for axial play in the U-joint (2). There should be zero play.

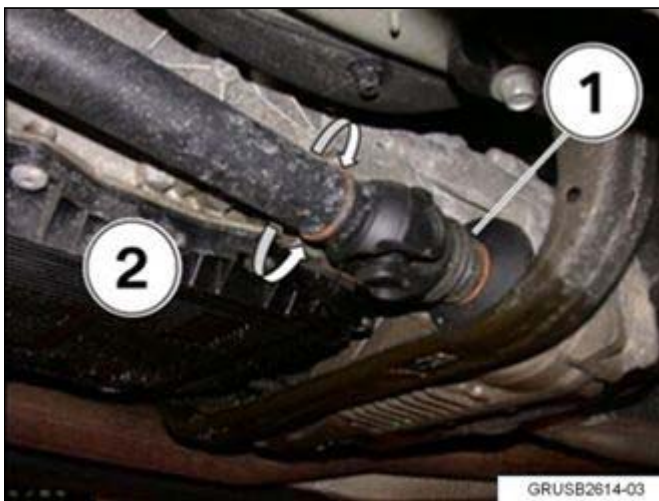
2. Checking the Rear U-joint:

Hold the output flange (1) on the transfer case and check for axial play in the U-joint (2). There should be zero play.

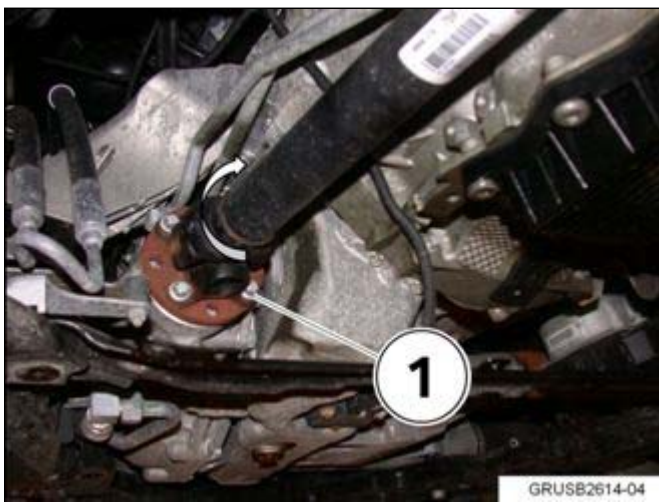
3. Rotate the driveshaft 90° and repeat steps 1 and 2. Rotate the driveshaft another 90° and recheck for play. Rotate a total of four times (the driveshaft has now been rotated 360° total). There should be no play in the U-joints.
