This Service Information bulletin supersedes SI B33 03 14 **dated May 2014**.

Service Action/Delivery Stop: Rear Shock Absorber Guide Support

F15 (X5)

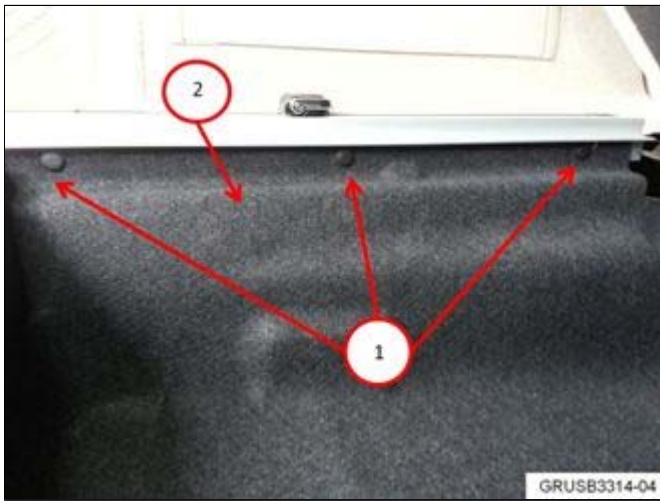
<p>Raise the luggage compartment floor. Remove the expanding rivets (1) from the left and right side of the luggage</p>
--	---

compartment pan (2) to expose the shock absorber guide support.

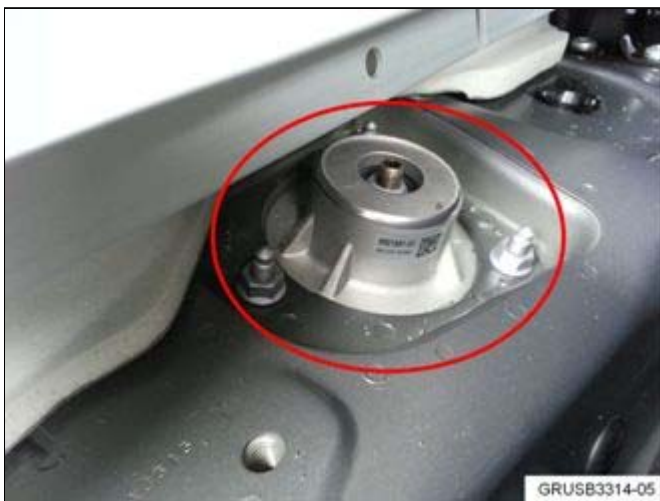
Check the parts label on the guide support.

NOTE: The left side of the luggage compartment is shown. It may be necessary to use an inspection mirror to identify the parts label on the right side guide support.

If the incorrect guide support is installed, replace it per Repair Instruction 33 52 161.

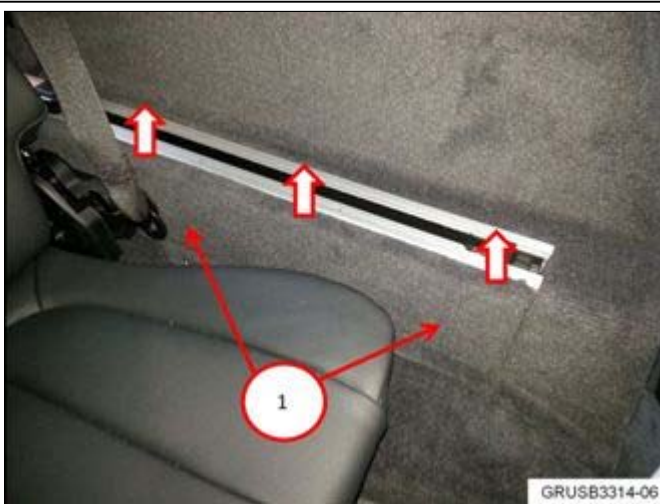
Fold out the third seat row to gain access to the bottom left and right trim panel (1).

Detach the trim panel (1) from the retainers towards the top.
