SUBJECT

RDC: Incorrect Tire Position Displayed with Air Pressure Drop

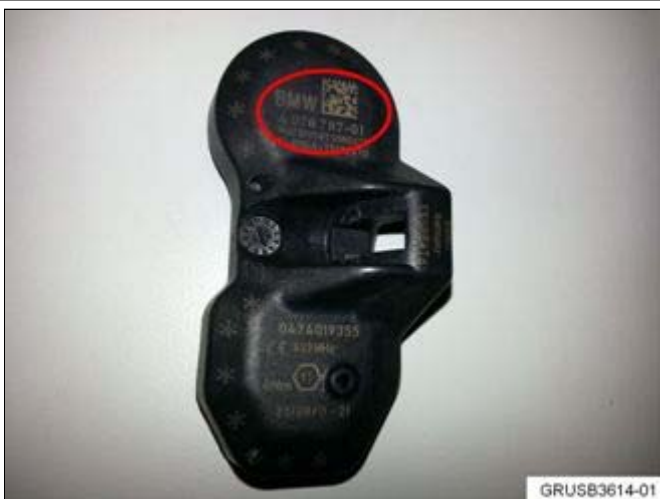
Software error in the RDC (tire pressure control) module in conjunction with wheel electronics part number 4 078 787 or 4 079 152

If P/N 4 078 787 or 4 079 152 is found, replace all four wheel electronics with P/N 36 10 6 856 227. If P/N 4 078 787 or 4 079 152 is **NOT** found, proceed as instructed by the ISTA test module and replace the indicated sensor.
Note: P/N 4 078 787 or 4 079 152 is easily identified by the stars that border the face of the wheel electronics, as seen in the picture to the left.

When P/N 4 078 787 or 4 079 152 are found, replace all four wheel electronics with P/N 36 10 6 856 227.
