**Service Action: Repair Corrosion Protection Engine Compartment**

F30 (3 Series Sedan)

F30H (ActiveHybrid 3)

Produced from June 2012 to January 2013

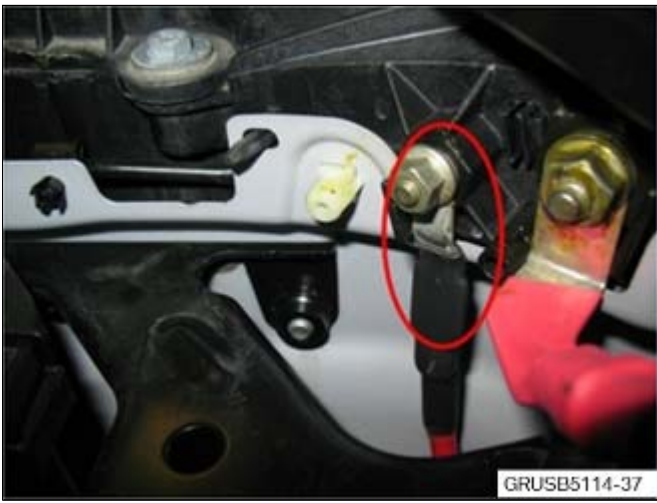
- Check that the battery positive cable installation is correct by inspecting the cable. Make sure the bend in the cable is away from the partition wall.
- This picture shows an incorrect installation of the cable: the cable might come in contact with the partition wall.
