**Service Action: Replace Center Console Lock Cylinder**

F01, F02 (7 Series)

Produced from March 7, 2014 to April 23, 2014

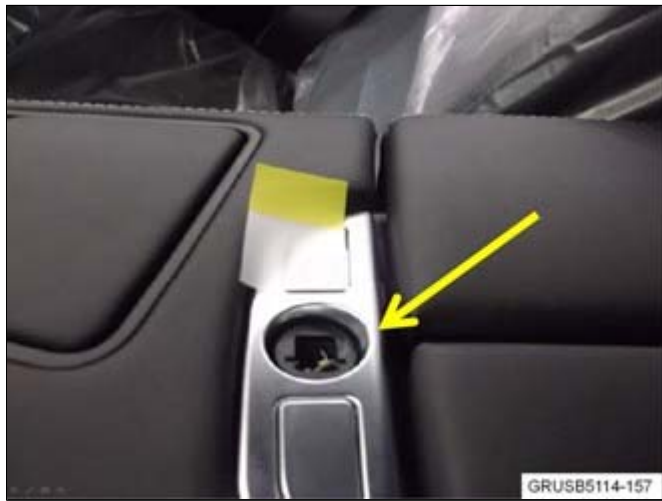
The center console lock cylinder is loose.

Manufacturing tolerances of the center console lock cover cap may cause it to become loose or missing.

| | <ol style="list-style-type: none"> <li>1. Locate the lock in the center console. In the photo, the key</li> </ol> |

cover cap is missing.

Replace the center console lock cylinder.
