### Various Electrical Faults Caused by Shorted K-CAN2

F25 (X3)

Produced to January 13, 2014

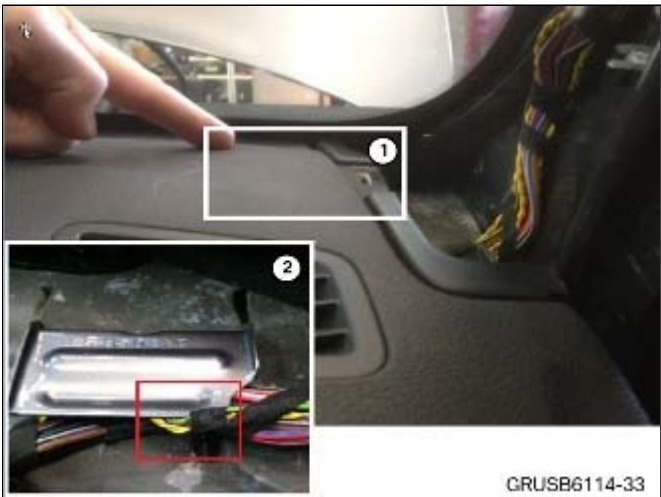
The wiring harness gets pinched between the instrument panel and the locating tab on the passenger side of the instrument panel.

K-CAN2 High – GE/RT (Yellow/Red)

K-CAN2 Low – GE/BR (Yellow/Brown)

Locate and repair the shorted wires. Reposition the harness.
