### Service Action: Check Wiring Harness for Electric Fuel Pump

F33 (4 Series Convertible)

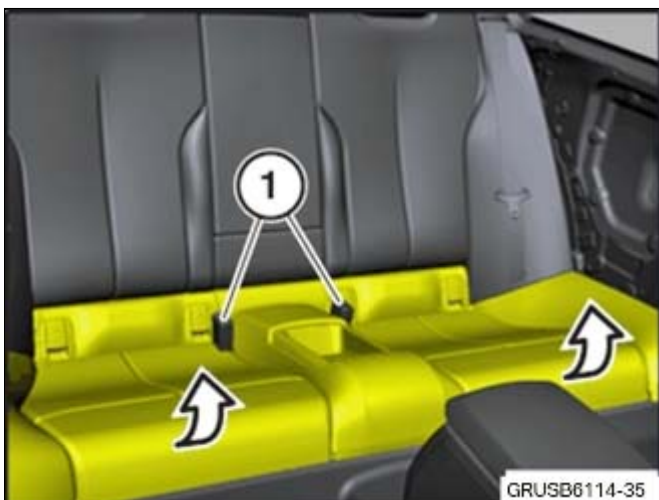
Remove the rear seat bottom and guide the seat past the belt buckles (1).

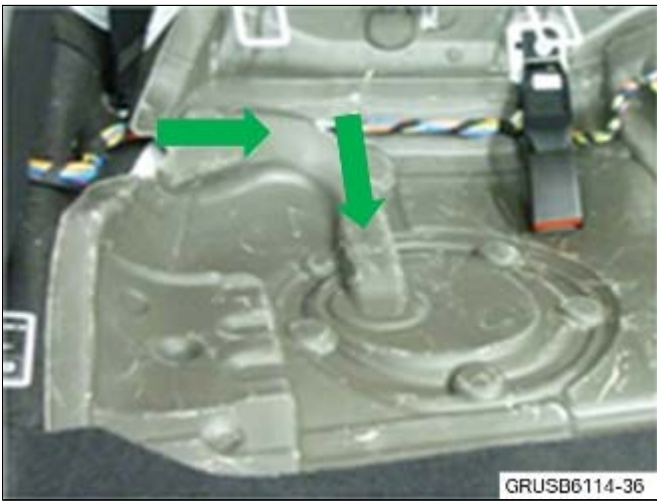
Lift up the insulation under the rear seat. The arrows indicate where the harness runs under the insulation.

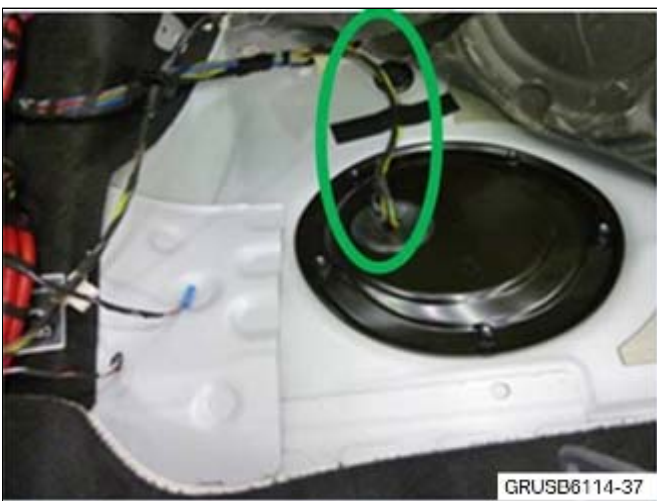
If the harness is routed and secured (taped) as shown, no further action is required.

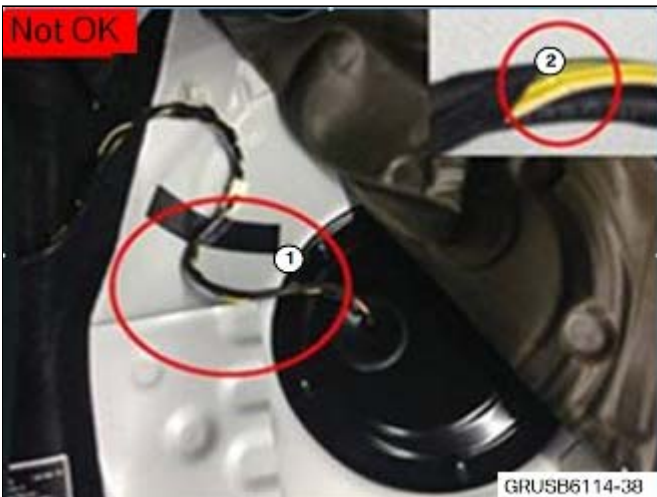
The wiring harness for the electric fuel pump may not have been routed or secured correctly. In unfavorable conditions, the wiring harness may come into contact with sharp edges on the fuel pump access cover. Continuous contact with the access cover can damage the wiring harness, which leads to fault codes stored and CC messages displayed.

Incorrect routing of the harness for the electric fuel pump.

If the harness is routed as shown (1), inspect the harness for any damage (2) and repair as needed. Reroute the harness. Secure as shown in the previous picture. Reinstall the insulation cover and rear seat bottom.

Check and, if necessary, reroute the wiring harness to the electric fuel pump.
