SUBJECT
A/C Operation: Reduced or No Airflow After Long Drive
MODEL

F15 (X5)

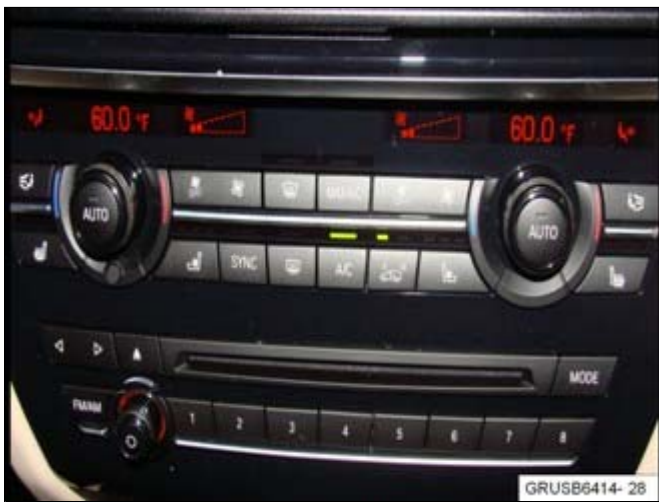
1. The customer A/C settings are typically below 63 deg F with a low fan setting of one or two LEDs.

At these settings, operate the A/C system and record the center outlet temperature. This measurement will be used for comparison after the resistor is installed.

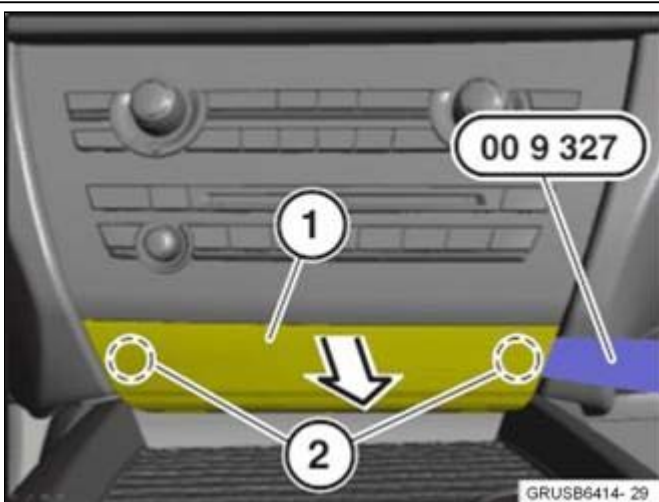
2. Remove the cover (1) using special tool 00 9 327 at the latch mechanisms (2), and remove the cover in the direction of the arrow.

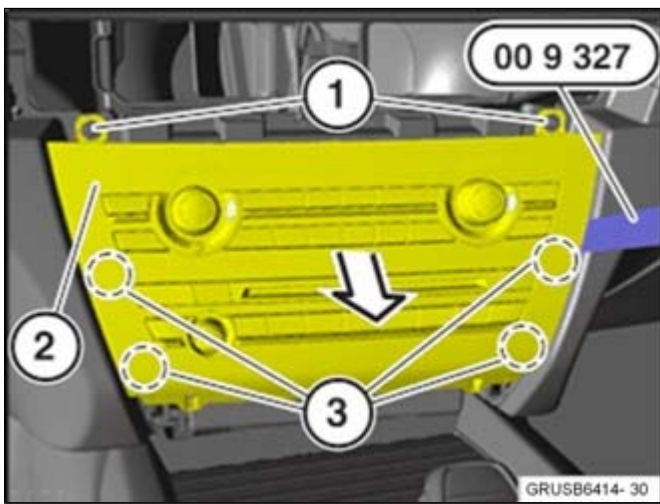
- Remove the screws (1), radio and IHKA controls (2) using special tool 00 9 327 at the latch mechanisms (3).

Remove the radio and IHKA controls (2) in the direction of the arrow, away from the dashboard.

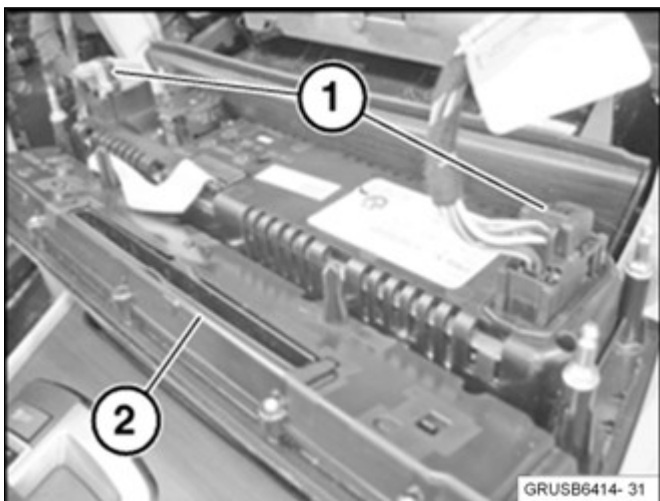
- Rotate the control panel downward to expose the plug connection (1) on the passenger's side.

- Locate plug connector X0018 and identify the violet evaporator temperature signal wire at Pin 10.

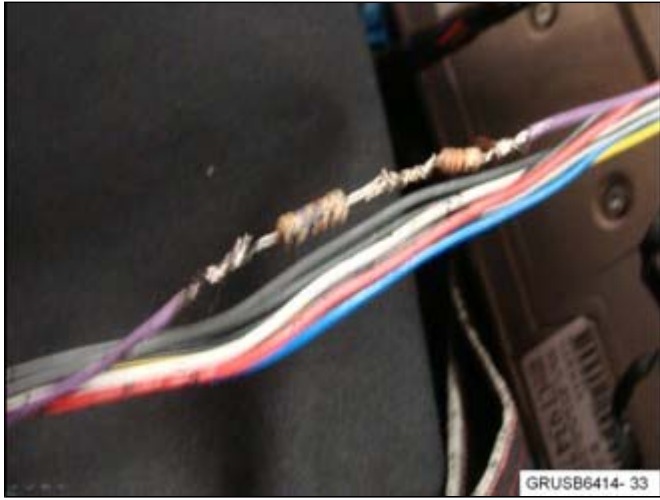
- The resistor is to be installed to the upper section of the harness. Working from the passenger seat, unwind the felt tape from the harness and cut the signal wire (pin 10) at a good working distance (3") from the plug connector. This will simplify the

resistor installation. In this case, the technician added two resistors in a series to reach the 800-ohm requirement and installed them approximately four inches from the IHKA plug.

7. Install the resistor and solder the connections neatly with no sharp points. Wrap the resistor and bare leads with electrical tape, and then re-wrap the wire harness with the original felt tape that was removed. Reassemble the removed parts in the reverse order of their removal.
