This Service Information bulletin supersedes SI M17 08 12 dated **January 2013**.

Service Action: Retrofit of the Engine Coolant Temperature Sensor

All with **automatic transmission** and either the N16 or N18 engine

This Service Action involves R55, R56, R57 and R58 MINI Cooper/Cooper S vehicles with the N16 or N18 engine which were produced from 8/2010 to 3/2012.

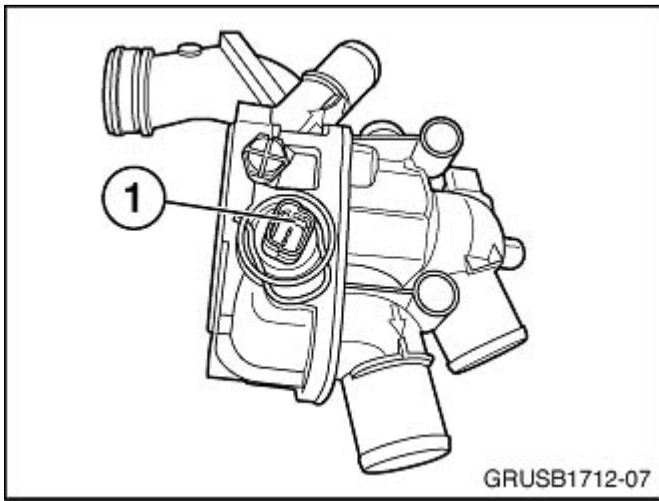
Checking for the updated thermostat: The P/N 11 53 7 534 521 thermostat has a replaceable engine temperature
--	--

sensor (1).

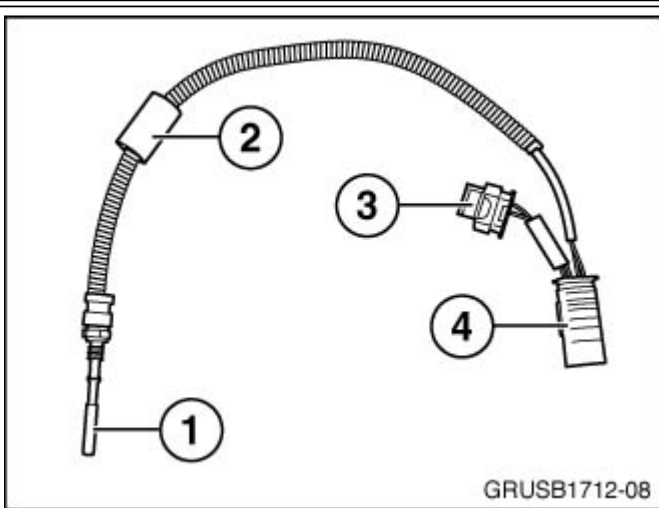
The improved sensor (P/N 13 62 8 603 908) includes the temperature probe (1) and insulating sleeve (2), a two-pin female connector (3) for the map thermostat, and a four-pin connector (4) for the engine harness.

Remove the fresh air intake tube and the charge air intake tube from the air box to the turbo to gain access to the engine harness at the thermostat.
