This Service Information bulletin supersedes SI M25 01 14 **dated July 2014**.

NEW **Service Action: Manual Gear Shift Knob Loose**

F56 (Hardtop)

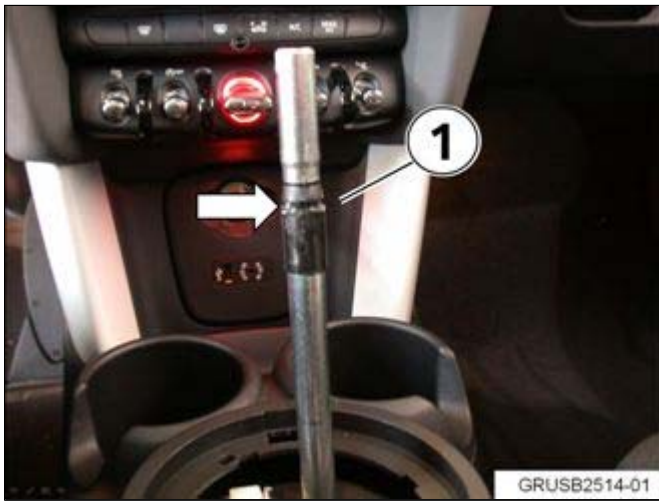
Pull the shift knob and boot completely off the shifter rod.
