Squeaking Noise When Operating Front Windshield Wiper

F56 (Cooper, Cooper S)

Produced from October 31, 2013 to April 30, 2014

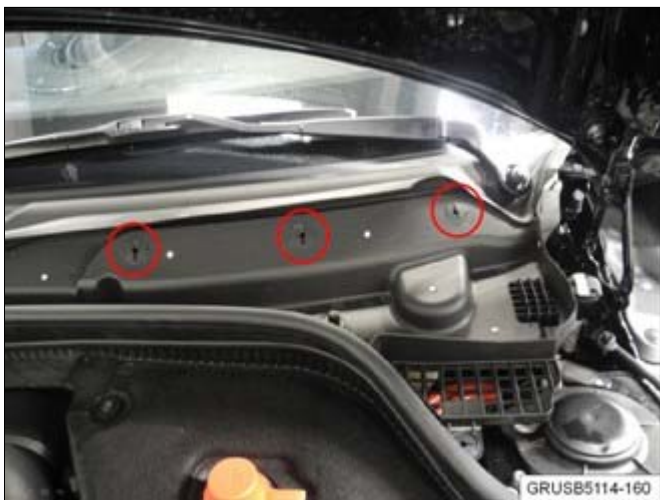
1. Check the three locking toggle fasteners on the driver's side trim cowl for correct installation.

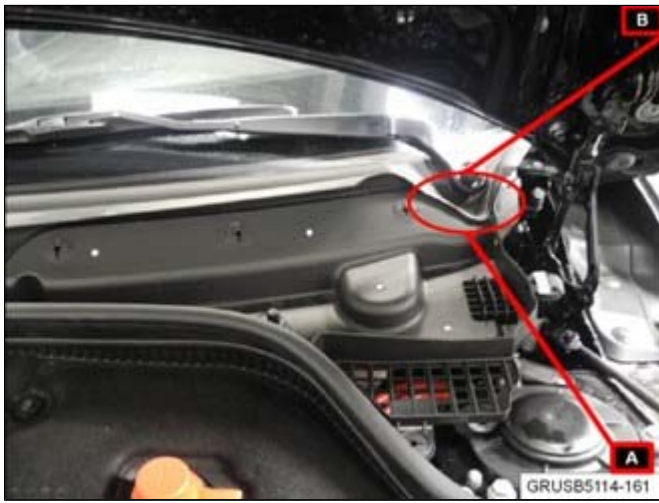
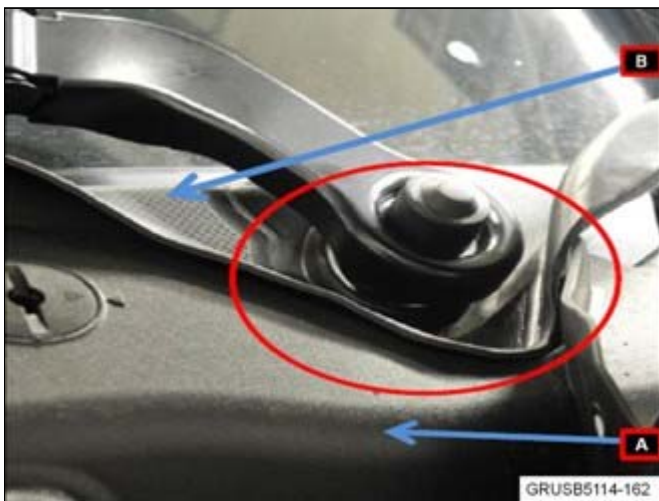
2. Check the position of the large cowl trim seal lip. The large cowl trim (A) must overlap the small cowl trim (B).

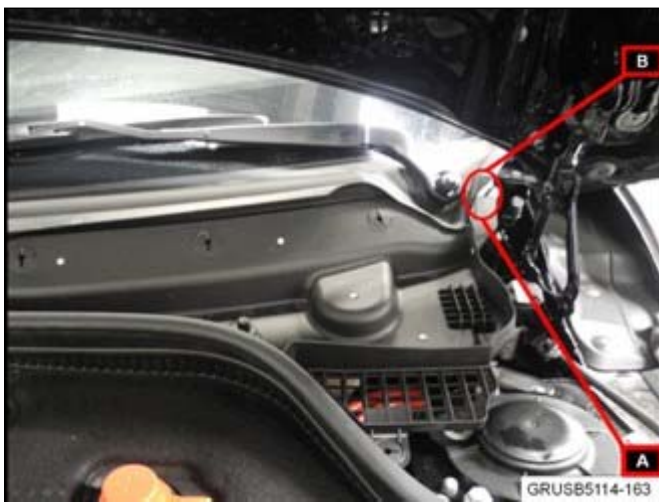
3. The close-up picture shows the correct cowl trim overlap. Reposition as needed.

4. Check that the securing lug is fully hooked in. The hook on the small left cowl panel trim (B) must be pushed under the large cowl trim (A).

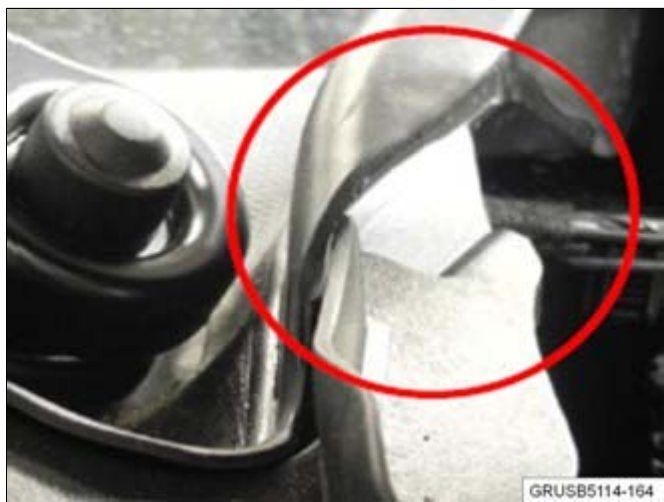
5. The close-up picture shows the correct position of the securing

lug overlap. Reposition as needed.
