N63 Engine: Check the Timing Chain

F01 and F02 (7 Series Sedan) produced from 3/2009 to 6/2012

This bulletin outlines the procedure to check the engine timing chains for wear and should be **completed in conjunction with [SI B11 06 14](#) “N63 Customer Care Package”**.

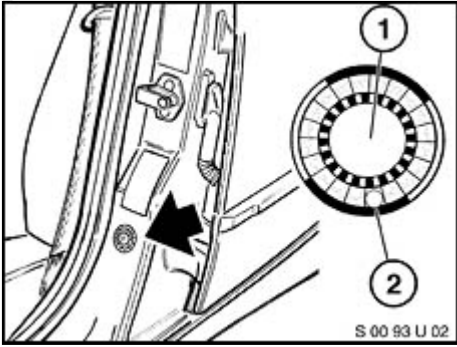
<p>This Service Action has been assigned code number 728. After the vehicle has been checked and/or corrected, obtain a label (SD 92-464) and:</p> <ol style="list-style-type: none"> A. Emboss your BMW center warranty number in the middle of the label (1); B. Punch out code number 728 (2), printed on the label; and C. Affix the label to the B-pillar as shown.
--	---

If the vehicle already has a label from a previous Service Action/Recall Campaign, affix the new label next to the old one. Do not affix one label on top of another one, because a number from an underlying label could appear in the punched-out hole of the new label.

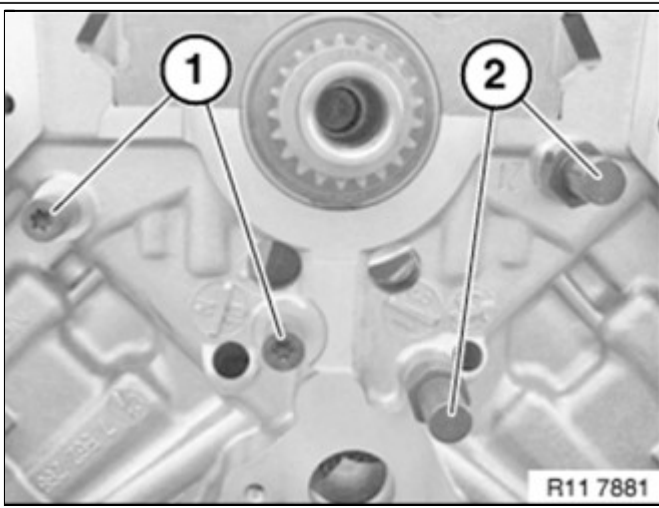
The current ISTA repair manual RA11 31 052 instructs to release tension on four bearing bolts (indicated as #1 for cylinders 5 to 8; and #2 for cylinders 1 to 4) on the engine block.

IT IS NOT NECESSARY TO PERFORM THIS.

DO NOT release these bolts because the bearing bolts are micro-encapsulated and they would have to be replaced in case of loosening up. The repair instructions will be updated soon.
