**Service Action: Retrofit Heat Insulators to Turbocharger Coolant Lines**

F06 (M6)

F10 (M5)

F12 (M6)

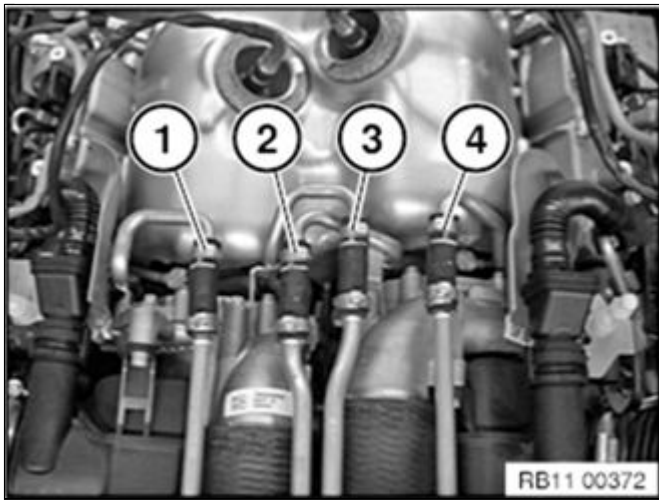
There is a possible coolant leak at the exhaust turbochargers.

Excessive heat buildup in the area of the turbocharger coolant lines

Check the coolant lines (1 through 4) at the turbochargers for any signs of leakage. Replace both the coolant

delivery line and coolant return line if there any leaks are found.  
Follow Repair Instruction RA 11 53 ...  
“Removing and installing/replacing coolant flow pipe and coolant return pipe for exhaust turbocharger (S63T 0) for coolant line replacement.”
