Service Action: Replace Convenience Charging Electronics (KLE)

I01 (i3 and i3 REx)

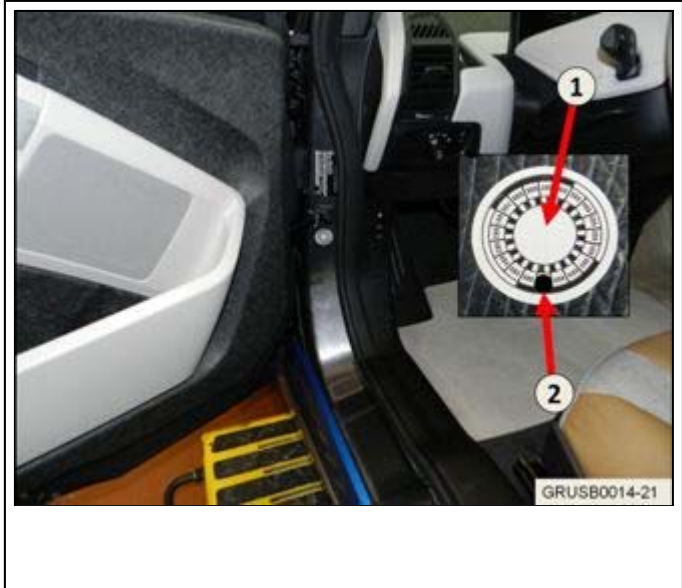
LABEL INSTRUCTIONS

<p>This Service Action has been assigned code number 717. After the vehicle has been checked and/or corrected, obtain a label (SD 92-453) and:</p> <ul style="list-style-type: none"> A. Emboss your BMW center warranty number in the middle of the label (1); B. Punch out code number 717 (2), printed on the label; and C. Affix the label to the A-pillar as shown.
---	---

If the vehicle already has a label from a previous Service Action/Recall Campaign, affix the new label next to the old one. Do not affix one label on top of another one because a number from an underlying label could appear in the punched-out hole of the new label.
