Service Action: Replace Neck Warmer Control Unit

F33 (4 Series Convertible)

F83 (M4 Convertible)

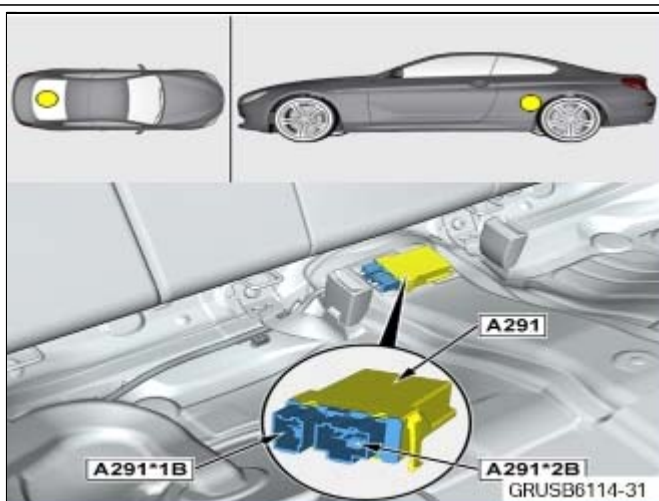
1. The control unit is located under the rear seat bottom, as shown in the photo, and is clipped in place.
2. Unplug the two electrical connectors and remove the neck warmer control unit.
