**SUBJECT****Central Information Display Intermittently Flashes Off/On****MODEL**

Produced from July 2013 to July 2014

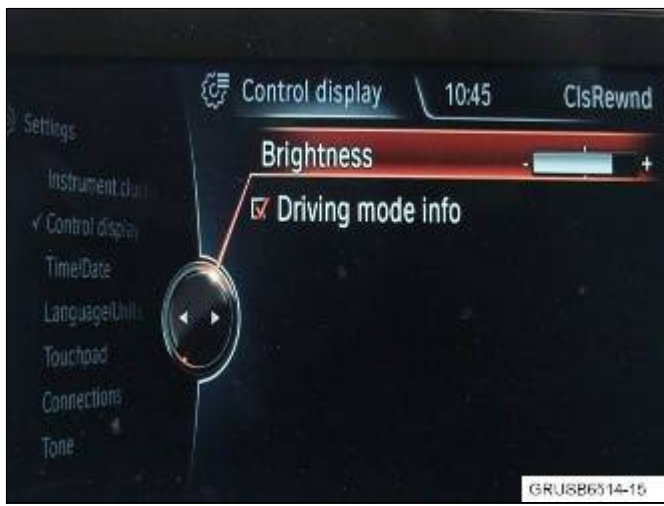
1. With the ignition turned on, check the brightness setting of the Central Information Display.

2. In the Main Menu, select Settings > Control display.
3. When the display brightness is set to 58% or higher, reduce the brightness setting to 50% or below.

4. Retest the function of the CID.
5. When the CID **no longer** flashes off/on, **replace the HU-H head unit**.

Only if the CID **still** flashes off/on, **do not replace the head unit**; instead, diagnose the APIX cable from the head unit to the CID and the CID itself.
