Front Doors Will Not Latch

R60 (Cooper Countryman, Cooper S Countryman, Cooper S Countryman All 4, JCW Countryman All 4)

R61 (Cooper Paceman, Cooper S Paceman, Cooper S Paceman All 4, JCW Paceman All 4)

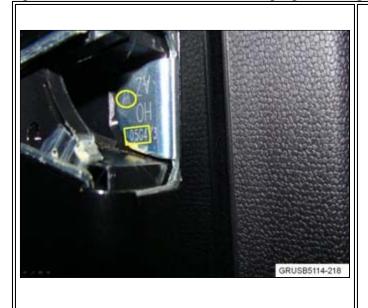
1. The picture shows the door lock with the M (Magna) and date code 05G4.

The 4-digit date code translates to:

If the Magna door lock date code falls between January 20, 2014 (20E4) and February 28, 2014 (28F4), both door locks must be replaced.

Replace both front door locks based on the vendor and door lock date code.
