Service Action: Inspect Front Driveshaft

E70 (X5)

E71 (X6)

E72 (X6 ActiveHybrid)

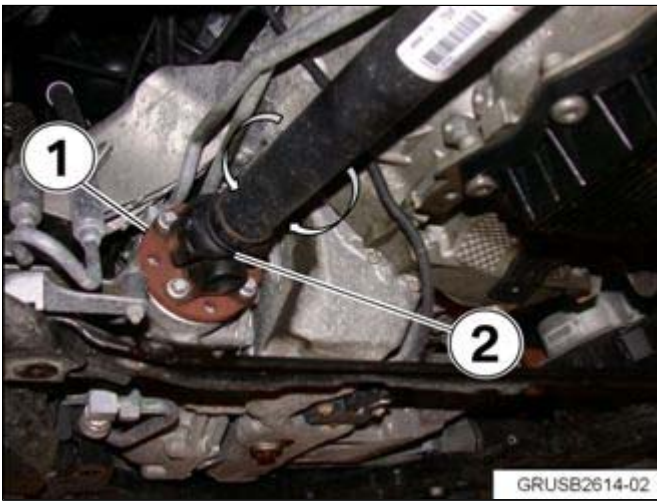
1. Checking the front U-joint:

Hold the input flange (1) on the front differential and check for radial play in the U-joint (2). There should be no excessive play.

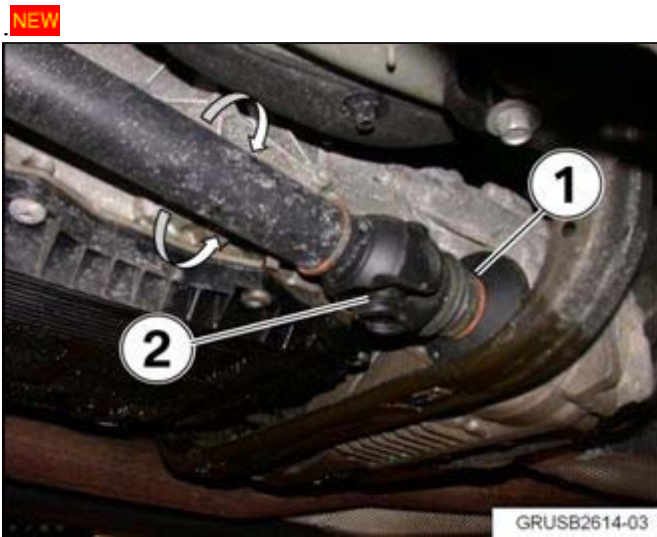
2. Checking the rear U-joint:

Hold the output flange (1) on the transfer case and check for radial play in the U-joint (2). There should be no excessive play.

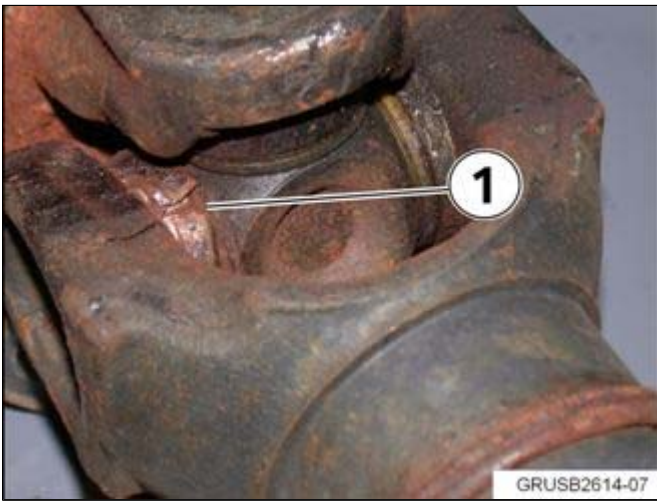
1. **NEW** There should be no cracking or damage at the bearing seals (1).

NEW If any of the above conditions are present, replace the driveshaft. Refer to Repair Instruction 26 20 000, "Removing and installing front propeller shaft as of 4/2010."

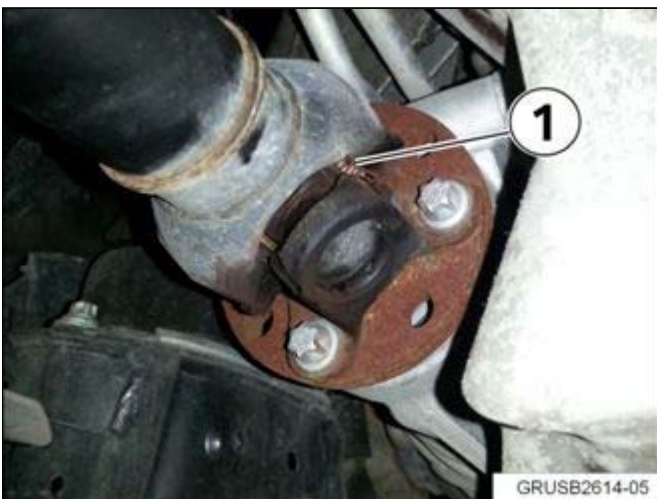
2. **NEW** There should be no exposed needle bearings (1).

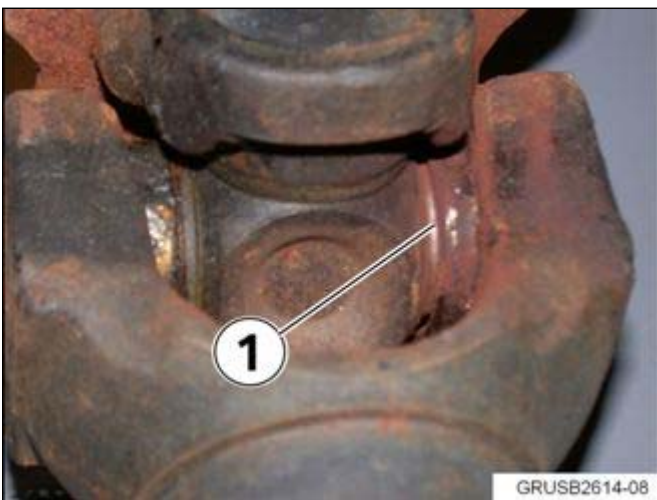
3. **NEW** There should be no excessive rust at the bearing seals (1). Note: There will be rust buildup on the driveshaft and mounting flange on some driveshafts. This rust is normal. Only excessive rust on the bearing seals indicates the seal may fail.
