**SUBJECT****Clicking Noise from Front Axle****MODEL**

F15 (X5)

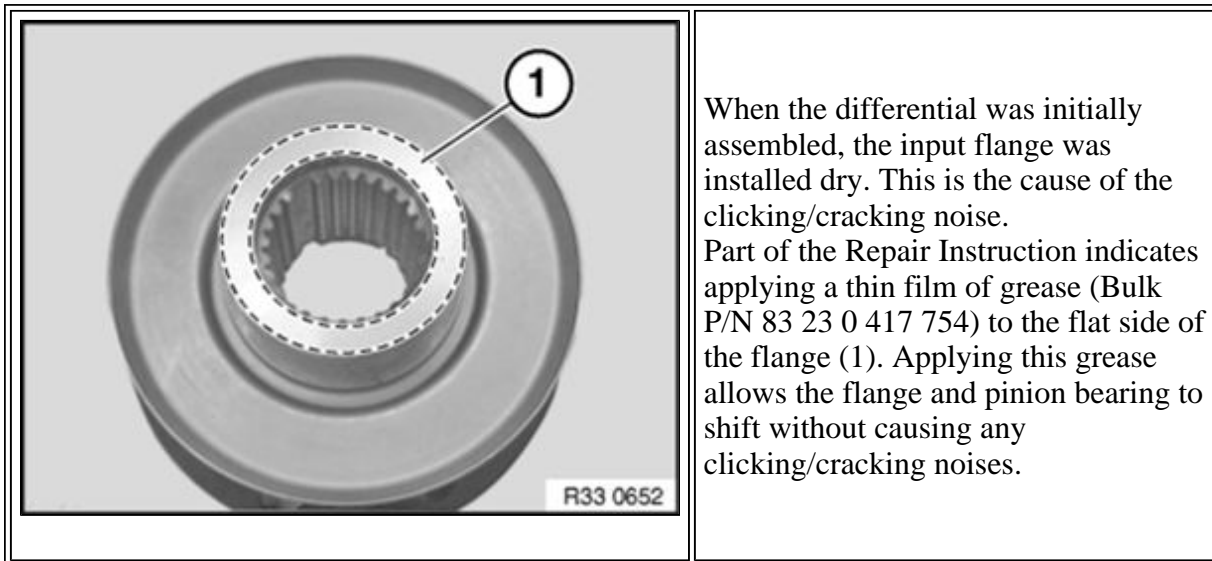
A high-pitched metallic clicking noise is heard from the front axle when taking off from a stop or during a load reversal (reverse to drive).

The preset axial play in the input flange to pinion bearings of the front differential may create a metal-on-metal "crack" noise when load reversing.

Remove the input flange from the front differential (refer to Repair Instruction RA 31 51 010).

**Do not replace any parts when performing the repair (the input flange seal stays installed).**

Reinstall the flange as described in the Repair Instruction.
