This Service Information bulletin supersedes SI 34 06 13 **dated May 2014.**

**NEW** Brake Disc and Brake Pad Service and Reference Information

All except M vehicles

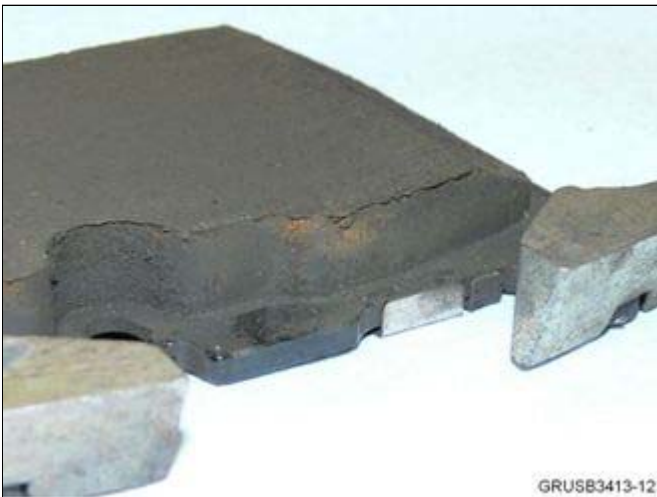
### 1. Brake Noise

**NEW** Most brake squeal noise is produced by vibration of the brake components. This vibration/oscillation will build up a resonance which is heard as a brake squeal.

**NEW** The type and occurrence of this noise varies, based on driving profile, environmental conditions and build up of debris on brake components.

Submit a PuMA Info Only case when servicing the vehicle for a customer complaint of brake noise.  
Include in the case:

- Identifying the correct axle
- Photos of the pads, discs and calipers
- Sound recording/video of noise occurring

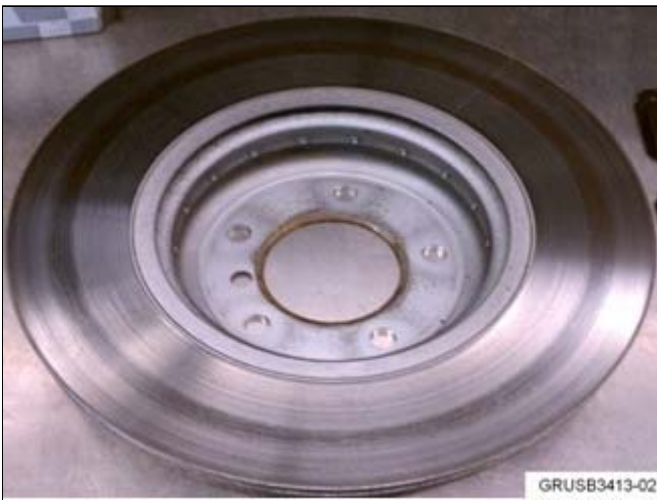
## 2. NAO-specific color transfer since 2009 introduction

Non-asbestos Organic (NAO) brake pad material, by design, reduces brake dust and may generate a visible dark transfer layer between pads and discs. This behavior is specific to the state-of-the-art technology found in NAO pad material.

The pad compound incorporates nonferrous metal, which can affect the appearance of the brake discs.

Color transfer on friction surfaces: With heavy or extreme braking, color transfer to the disc from the pads is intensified and may generate dark spots or circular traces. Normal braking will gradually reduce the discoloration.

This will not affect braking performance.

No repair attempt is needed.

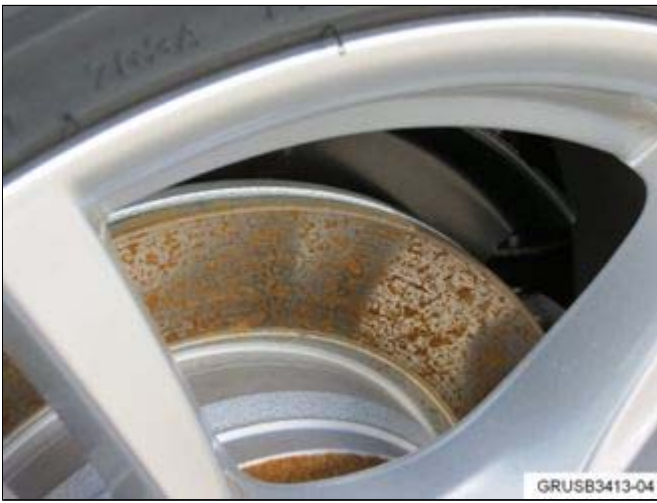
## 3. Light rust on friction surfaces

**NEW** Brake disc friction surfaces are exposed metal. When not in use and exposed to environmental elements (moisture, salt, dirt), surface rust can form. During initial braking, this will self-clean and an audible groan and/or noise is temporarily heard until the disc surface is cleaned. This will not affect braking

performance.  
No repair attempt is needed.

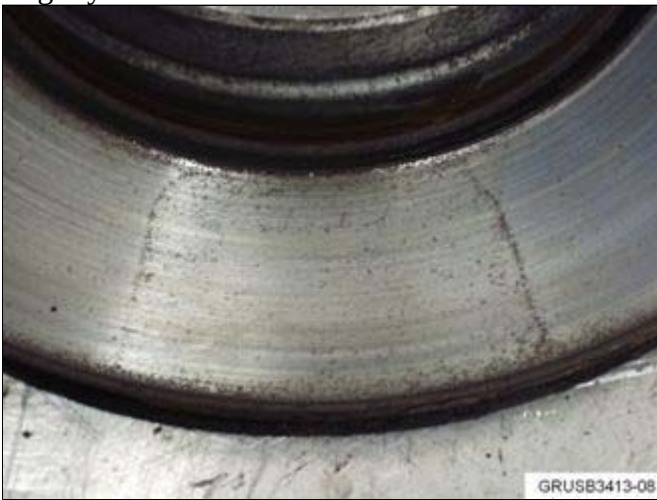
Slightly stained

**NEW** Slight traces of corrosion on the brake disc friction ring (remains of stained spots): this is the normal condition of a vehicle that is stationary and has not been in use.

**NEW** This corrosion varies with ambient elements.

**NEW** The appearance will not affect braking performance and will diminish with everyday use.

**NEW** No repair attempt is needed.

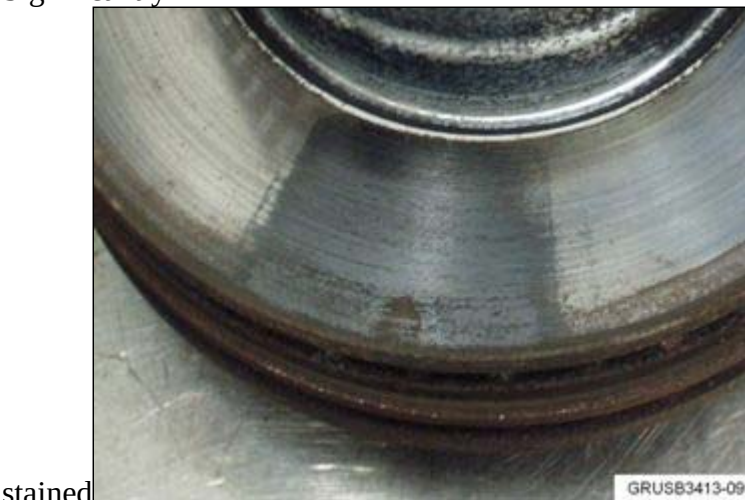
Significantly

**NEW** Significant signs of corrosion on the friction ring: this is the normal condition of a vehicle that is stationary and has not been in use.

**NEW** This corrosion varies with ambient elements.

**NEW** The appearance will not affect braking performance and will diminish with everyday use.

**NEW** No repair attempt is needed.

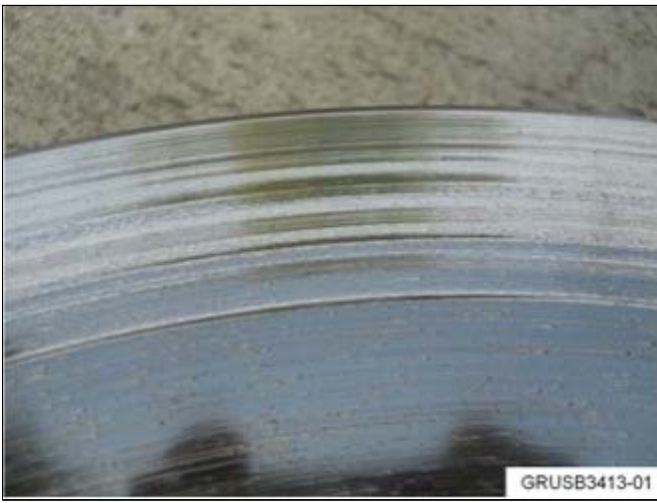
#### 5. Grooves

Grooves are formed when debris is trapped between the pad and the disc. Debris entry is inherent in the disc brake cooling design. Current wheel styling exposes more of the brake components.

Grooves in the brake discs can be seen through these wheel openings and are purely visual; this in no way affects braking performance. No repair attempt is needed.

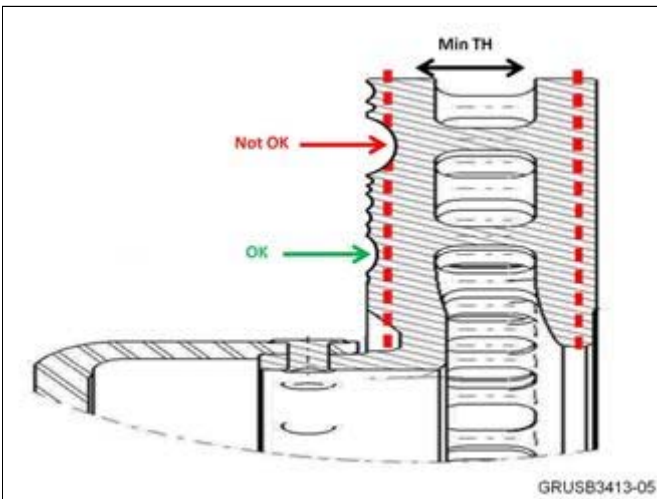
However, the groove depth must be evaluated to determine if replacement is necessary.

If the groove's or grooves' depth goes beyond the minimum thickness, disc replacement is necessary.

- Always refer to the Repair Manual for model-specific information.
- Always replace discs in pairs (per axle).
- Install new brake pads when replacing discs.

Attach a hang tag to the inside rearview mirror after completion of repair work.

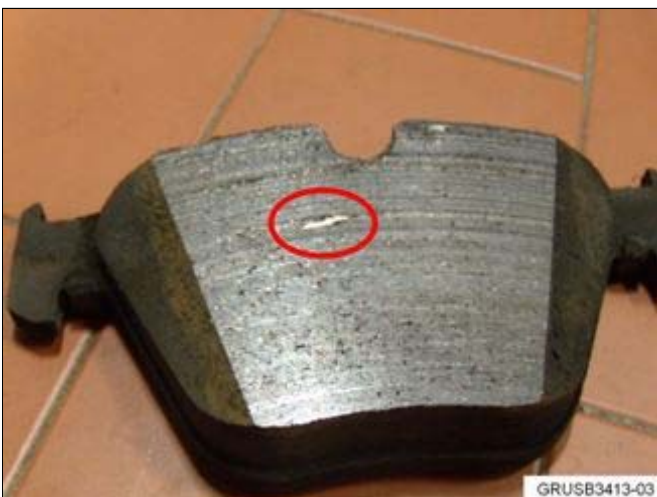
## 6. Embedded Material in Brake pad

Improper "bedding in" of the new brake pads and discs can cause the rotor material to flake off. This debris can become lodged in the pads and cause this appearance.

This appearance will not affect braking performance.

No repair attempt is needed

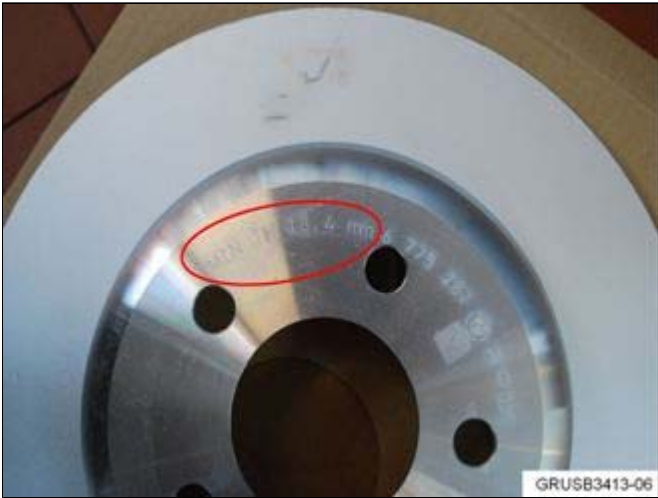
## 8. Minimum Thickness

BMW brake discs are stamped with a minimum thickness value. The stamped minimum thickness is used to determine if the brake discs require replacement during a brake service. Some motor vehicle inspection procedures (state-dependent) require the measurement of brake discs for safety consideration. A separate minimum thickness specification is provided in the Repair Manual. An example of the specifications is described below.

The Minimum Thickness for general inspection (Motor Vehicle Inspection) is defined as follows:

- New disc thickness minus 2.4 mm (not applicable to perforated brake discs and M vehicles)

- Always refer to the Repair Manual for model-specific information.
- Always replace discs in pairs (per axle).
- **NEW** Install new brake pads when replacing discs.

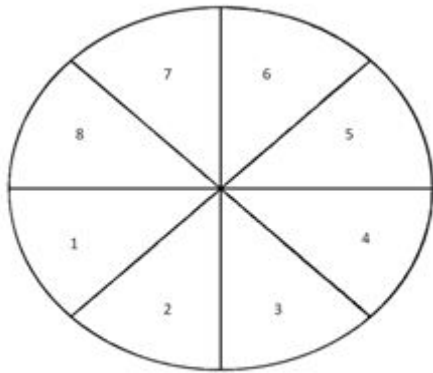
GRUSB3413-11

**NEW** The thickness difference is measured with a micrometer at 8 points around the braking surface. The thickness difference of the brake disc is maximum 0.020 mm. If readings deviate beyond 0.020 mm, replace the brake discs.

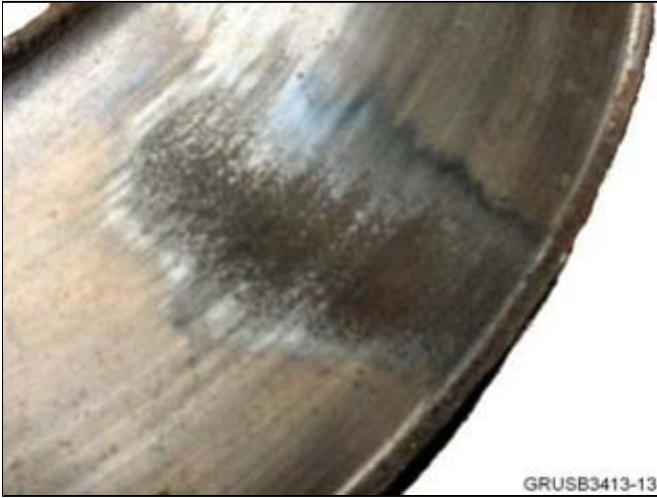
## 10. Brake Overheating

Discoloration and/or visible hard spots indicate brakes that have overheated. Inspect the brake components for error-free operation (calipers binding, hydraulic restrictions, etc.). If no mechanical/hydraulic defects are found, this can be attributed to improper brake usage. In this case, the discs have to be replaced (not under

warranty).

- Always refer to the Repair Manual for model-specific information.
- Always replace discs in pairs (per axle).
- Install new brake pads when replacing discs.
- Attach the hang tag to the inside rearview mirror after completion of repair work.
