SUBJECT
Rattling Noise from Mid-range Speaker in Front Door Panel
MODEL

F10 (5 Series)

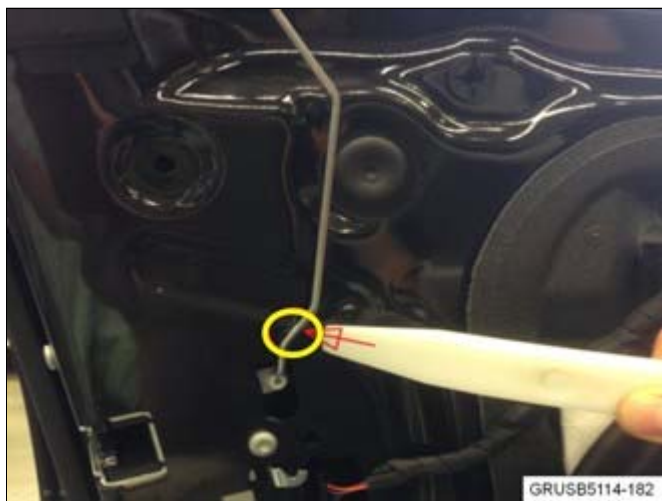
The customer complains of a rattle noise in either the left or right front door only when the speakers are in use.

The inside door lock rod is making contact with the inside panel when the speakers are in use at certain volume and frequency levels.

Remove the affected front door panel trim (the driver's door is shown).

Locate the door lock rod and the area where the felt tape will be applied. Prepare a piece of felt tape 20 mm long by 10 mm wide. Clean the area with a rag. Wrap the felt tape to the area shown. Reinstall the removed door panel in the reverse order of its removal.
