June 2014 Technical Service

# Front Windshield Washer Jets Not Working

F56 (Cooper, Cooper S)

Produced from SOP to February 2, 2014

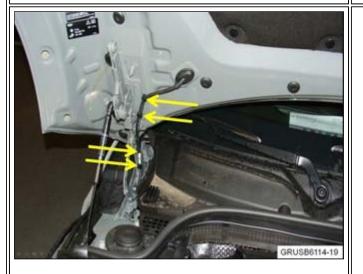
The windshield washer hose shown below is too short. This causes it to kink or disconnect.

1. Open the bonnet and locate the washer hose to be replaced near the passenger's side gas strut, attached to the bonnet.

Replace the front windshield washer hose with a new longer version.
