US 22898888-05

Clutch does not open fully on G650 models with Rotax engine

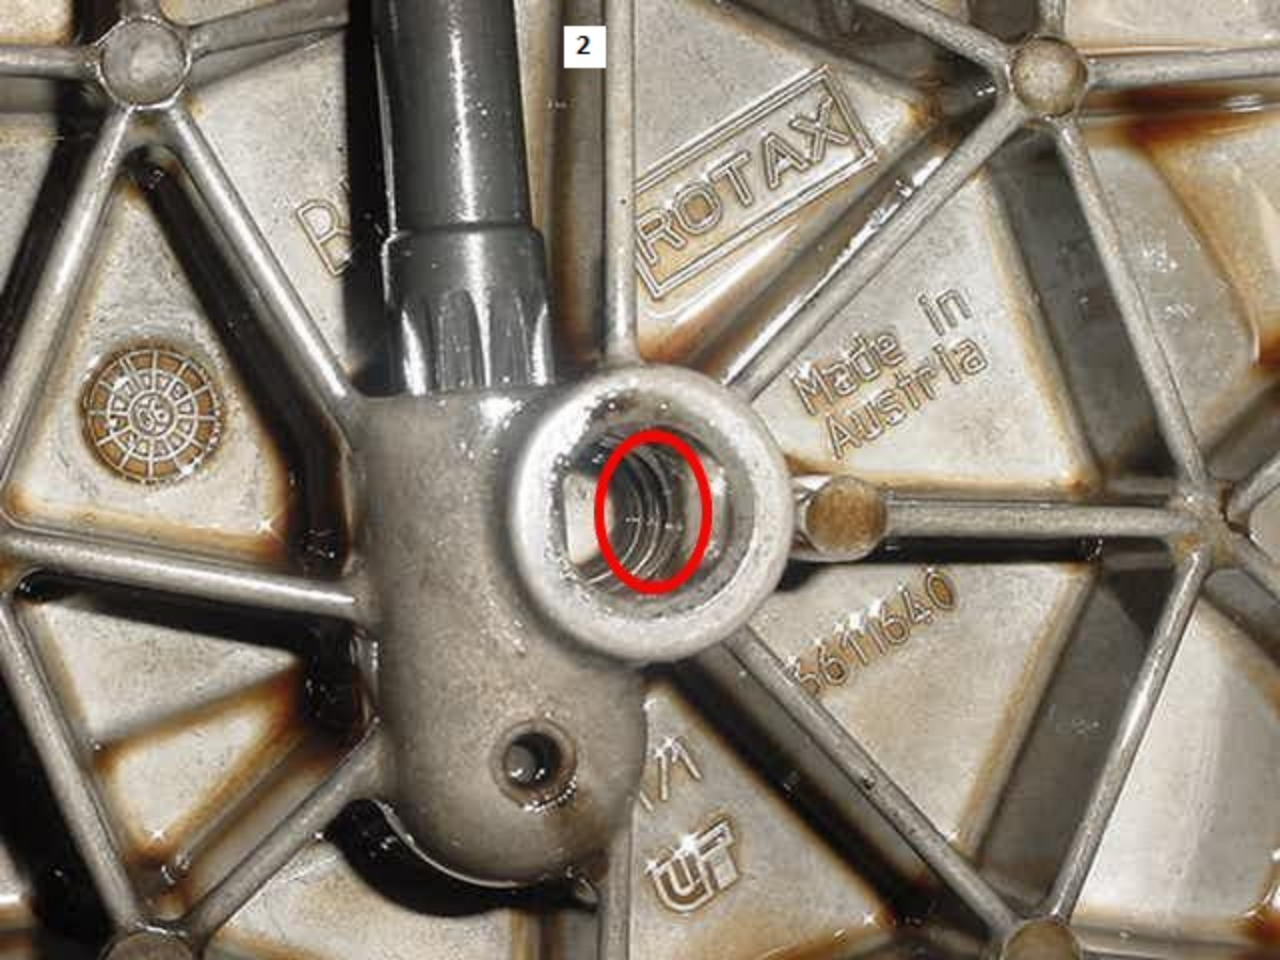
Wear to release bearing guide (attachment: picture 1) in the ROTAX clutch housing cover (attachment: picture 2).

Installation of LONCIN clutch housing cover 11147700331 in conjunction with new release bearing 21217709526 and actuating shaft 21217700306.

In the LONCIN clutch housing cover, the release bearing is supported in a cast iron bush, unlike the Rotax clutch housing cover.
