| US 59123693-02 | The windscreen is breaking away at the fastening points. | |

All windscreens for the R 1200 GS (K50) and the R 1200 GS Adventure (K51) have been changed.

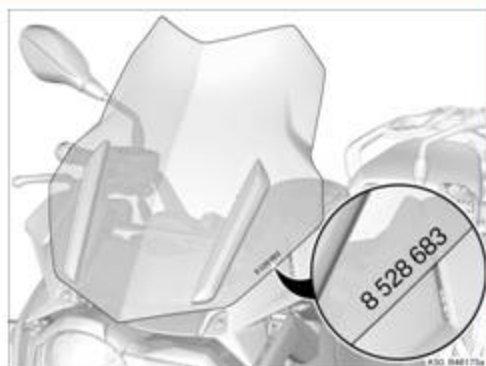
K50

The construction status can be identified by the part number on the windscreen.

< 06/2014
