**SUBJECT****S63TU Engine: Noises from Leaking Exhaust Manifold****MODEL**

F10 (M5 Sedan)

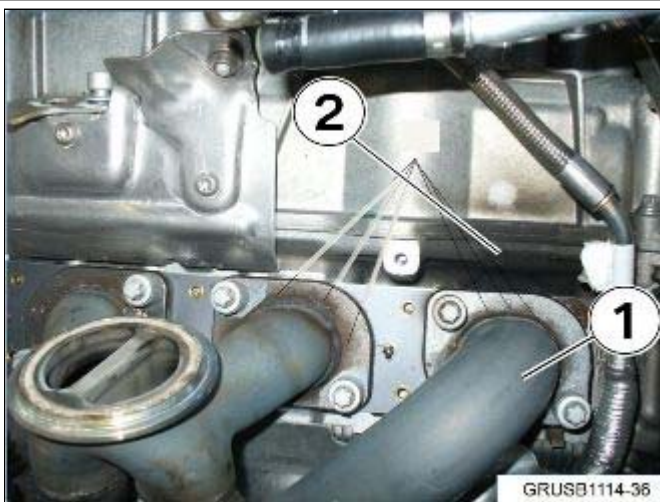
The exhaust manifold attaching screws have come loose, causing an exhaust leak.

1. Inspect the sealing area where the exhaust manifold (1) contacts the cylinder head. If exhaust gas is leaking, a blackened area will be seen on the cylinder head surface (2).

Note: In the photo, the engine is partially disassembled for clarity.

2. If found to be leaking, replace both exhaust manifold to cylinder head gaskets as per Repair Instruction 18 14 10, "Removing and installing/renewing left exhaust manifold (S63T 0)" and Repair Instruction 18 14 20, "Removing and installing/renewing right exhaust manifold (S63T 0)."
