Service Action: Program Control Units (Fuel Shut-off Valve)

F02H (ActiveHybrid 7)

F10H (ActiveHybrid 5)

F30H (ActiveHybrid 3)

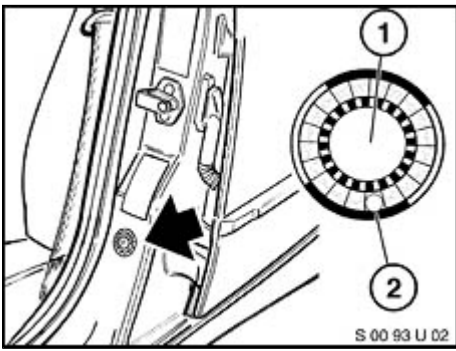
- A. Emboss your BMW center warranty number in the middle of the label (1);
- B. Punch out code number **677** (2), printed on the

label; and

- C. Affix the label to the B-pillar as shown.

If the vehicle already has a label from a previous Service Action/Recall Campaign, affix the new label next to the old one. Do not affix one label on top of another one because a number from an underlying label could appear in the punched-out hole of the new label.
