Service Action: Inspect Front Driveshaft

E70 (X5)

E71 (X6)

E72 (X6 ActiveHybrid)

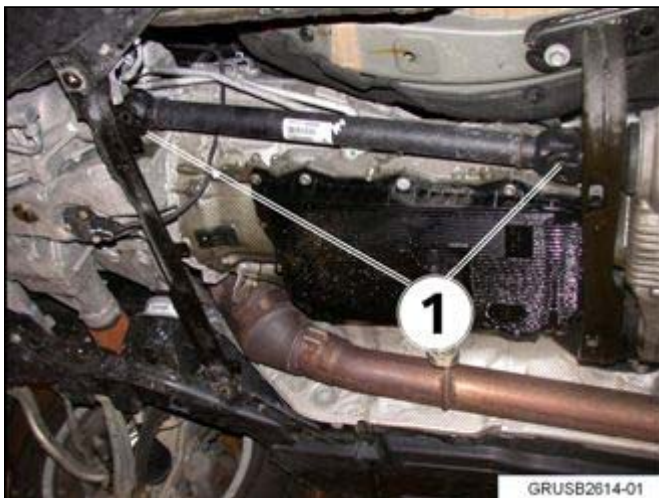
Check the universal joints in the front driveshaft for axial play (1).
Note: The E72 will need to have the reinforcement plate removed to check the driveshaft U-joints. Refer to Repair Instruction 31 10 010, "Removing and installing/replacing reinforcement plate."

The driveshaft will need to be replaced if any play is found in the U-joints. Refer to Repair Instruction 26 20 000, "Removing and installing front propeller shaft as of 4/2010."

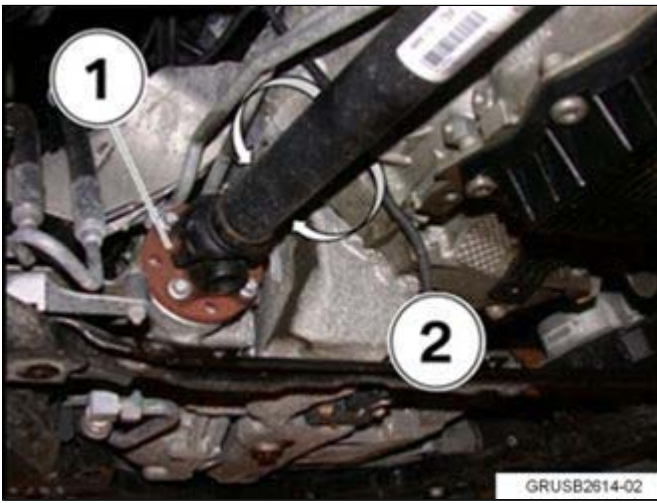
1. Checking the Front U-joint:
Hold the input flange (1) on the front differential and check for axial play in the U-joint (2). There should be zero play.

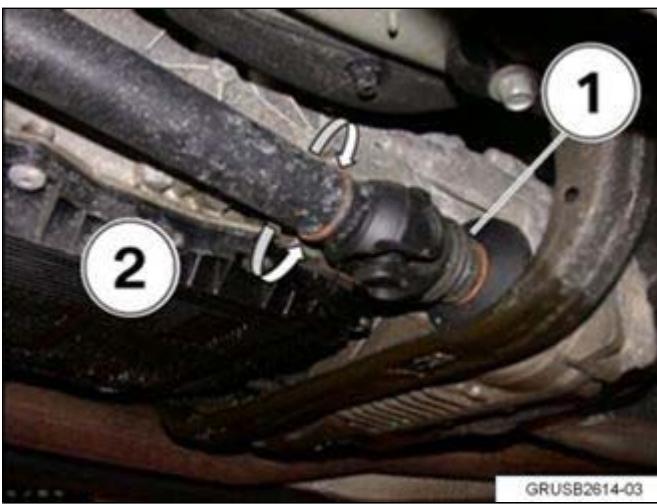
2. Checking the Rear U-joint:

Hold the output flange (1) on the transfer case and check for axial play in the U-joint (2). There should be zero play.

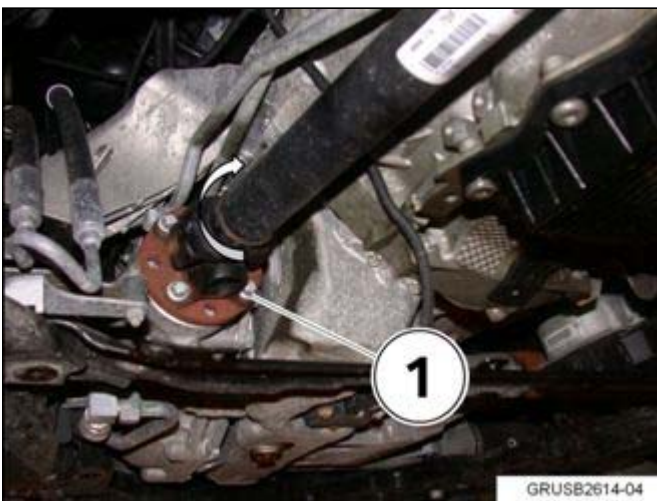
3. Rotate the driveshaft 90° and repeat steps 1 and 2. Rotate the driveshaft another 90° and recheck for play. Rotate a total of four times (the driveshaft has now been rotated 360° total). There should be no play in the U-joints.
