**Service Action: Repair Right Side Panel Corrosion Protection**

F32 (4 Series)

Produced in July 2013

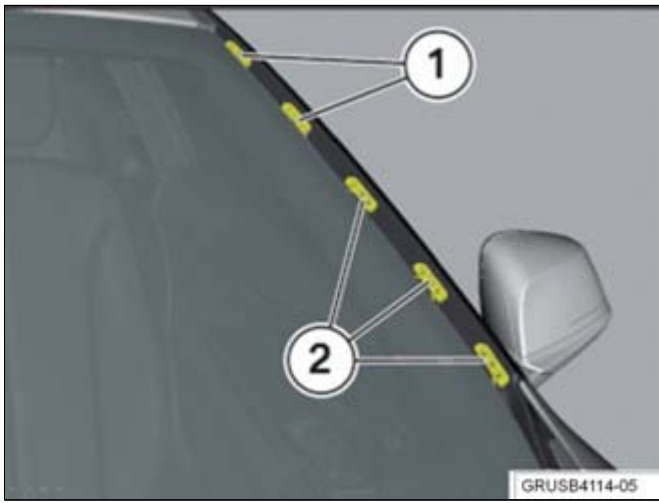
<p>1. Unclip the gutter strip (1) and pull upwards out of the clips (2).</p> <p>Installation note:</p> <p>Gasket (3) of the gutter strip (1) must lie against the windshield over the entire length (4).</p>
--	--

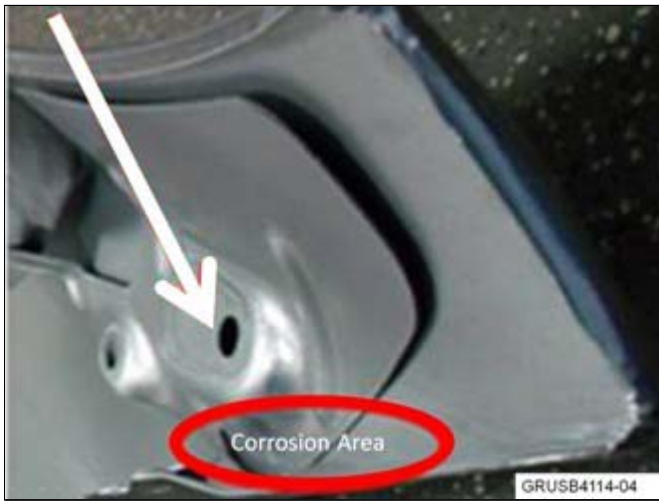
Shown is the underside of the removed side panel trim for clarity. There is no need to remove the panel.

The white arrow shows where the cavity spray tube will protrude after being inserted from the top. The red circle shows the area needing the additional corrosion protection spray.
