**Service Action: Repair Corrosion Protection in Engine Compartment**

F30 (3 Series Sedan)

F30H (ActiveHybrid 3)

Produced from September 2011 to May 2012

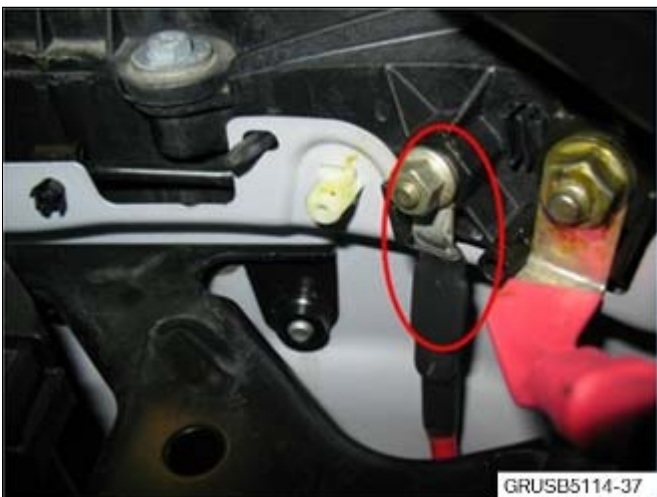
- Check that the battery positive cable installation is correct by inspecting the cable. Make sure the bend in the cable is away from the partition wall.
- This picture shows an incorrect installation of the cable: the cable might come into contact with the partition wall.
