Service Action: Repair Corrosion Protection in Engine Compartment

F30 (3 Series Sedan)

F31 (3 Series Sports Wagon)

Produced in February 2013

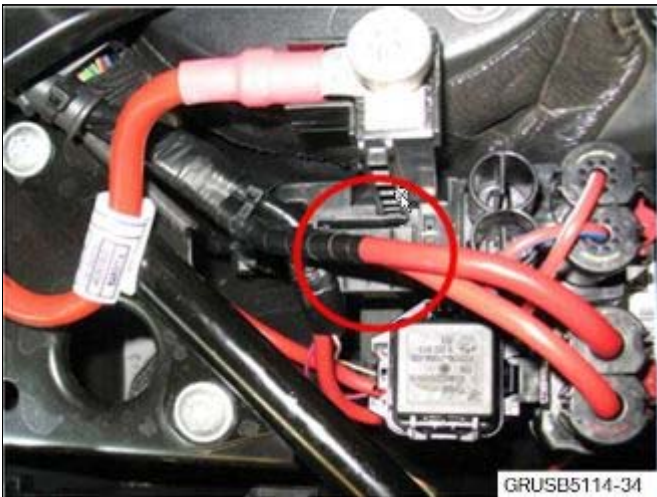
This picture shows the installation location of the cover to be replaced, below the battery positive cable.
