Front Door Loudspeaker Make Noises When Cold

F22 (2 Series Coupe)

F30 (3 Series Sedan)

F32 (4 Series Coupe)

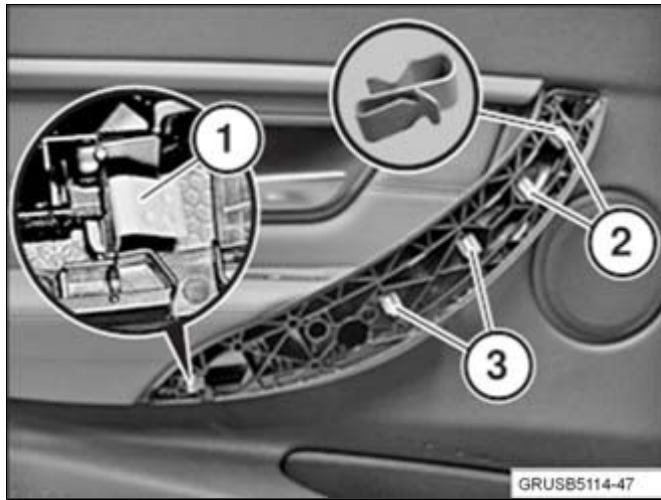
- Clamp (1) may bend upwards when dismantling the cover.

Bend the clamp (1) back by approx. 45° if necessary.

Replace any faulty clamps.

Make sure the installation location of the clamps (2 and 3) is correct.

- Clamps (2) silver

- Clamps (3) black

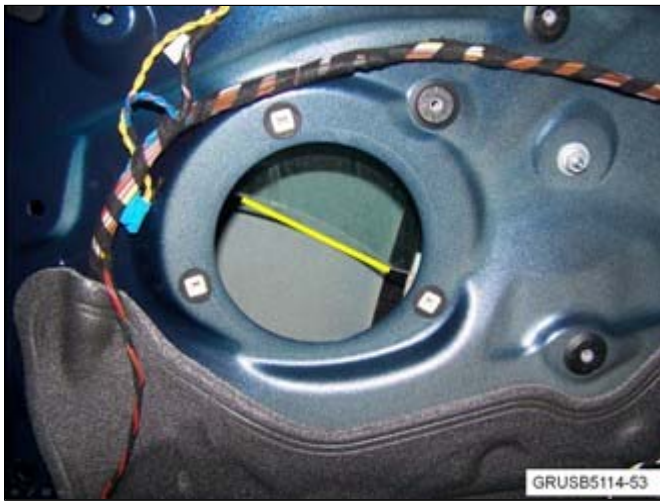
Water from the door window may enter the rear area of the front door medium range loudspeaker basket/cage and can solidify when the temperature drops below freezing, creating the noise.

8. Lower the door window until the

lower edge of the glass can be easily accessed through the speaker opening, as shown.
