**Activating Rear Window Washers Causes Front to Briefly Spray**

F15 (X5)

Produced from July 14, 2013 to May 30, 2014

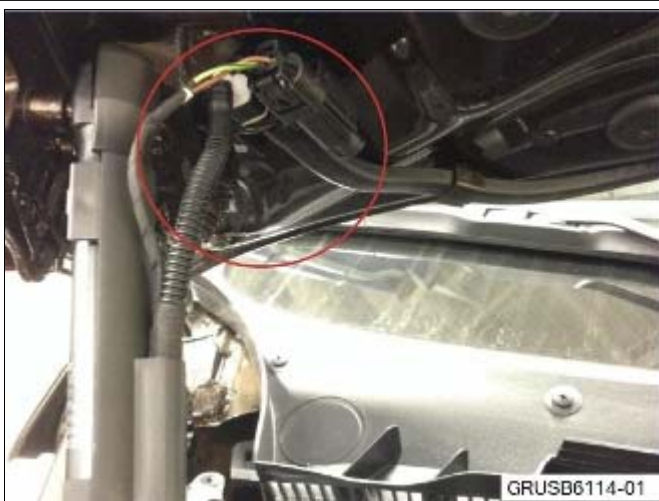
2. The area to be repaired is highlighted near the hood gas strut on the passenger's side of the vehicle.

1. Open the hood.
