**SUBJECT****One or Both Xenon Headlights Aiming Downwards****MODEL**

E90 (3 Series Sedan)

SITUATION

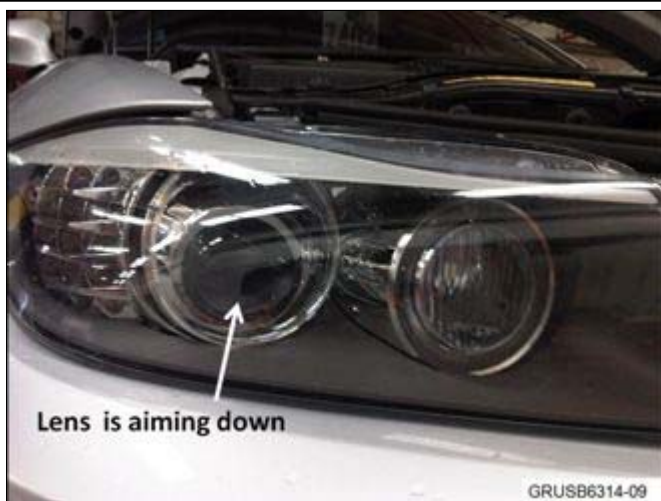
Both xenon headlight lenses are aiming downwards;
or
One xenon headlight lens is aiming downwards.
There is **NO** related CCM (Check Control Message).

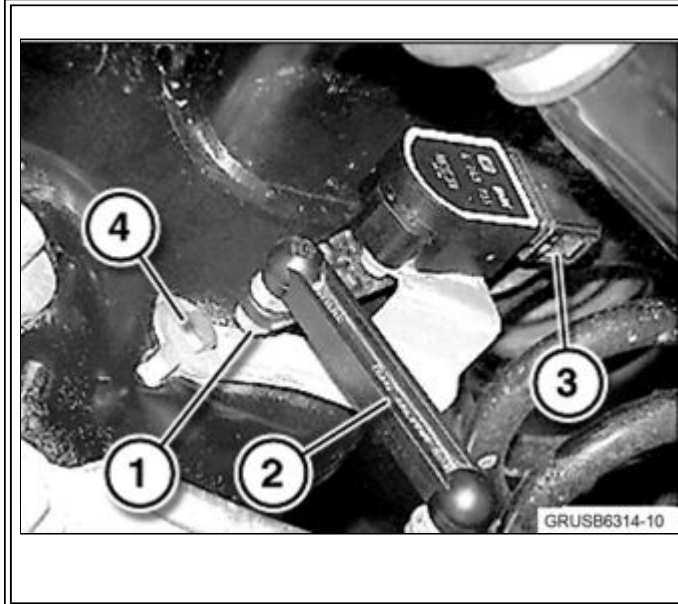
- The most likely cause is a faulty or disconnected rear height sensor.

1. Inspect the rear height sensor for the correct position. Check if the bolt (4) and bracket (1) are installed correctly and check the connector (3) for any damage or looseness.
2. If no visible problem is found, connect the vehicle to ISTA and check for faults related to the rear height sensor. Complete the test plan for the fault and follow the test plan recommendation. For more information, refer to REP 3714512, "Replacing rear ride height sensor."

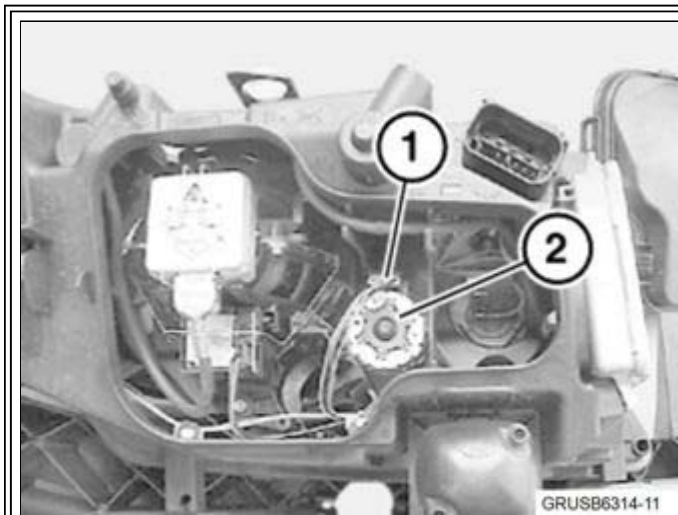
In most cases, the root cause is the ball socket separating from the bracket in the vertical aim adjuster mechanism inside the headlight assembly.

3. Remove the rear cover from the headlight and disconnect the connector (1). For more repair information, refer to REP 6716011, "Removing and installing/replacing left vertical aim adjuster (Xenon headlight)."
4. Twist the vertical aim adjuster (2) to remove it.

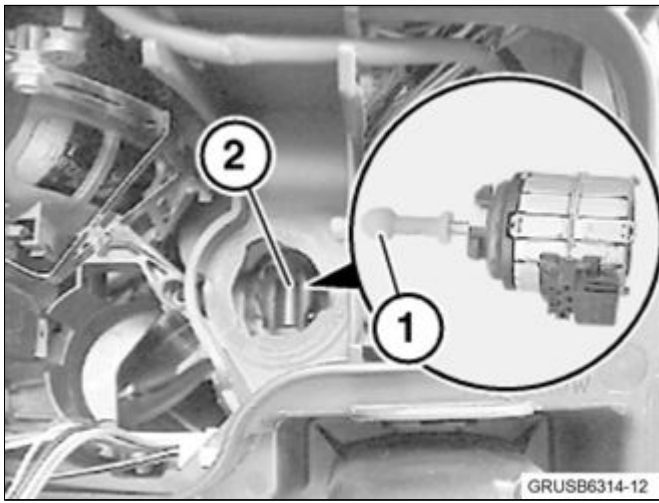
- The cause could be a “disconnected” vertical aim ball socket adjuster, resulting from excessive road

vibration or sharp impacts (pot holes) through the suspension to the headlight assembly.

5. If the ball (1) is disconnected from the bracket (2), reconnect by pushing the ball back into the

bracket. Make sure the other 2 pivots are also in place.

6. Make sure that ball stays in the bracket after the repair.
