### Window Regulators Squeak when Moving Up or Down

R55 (Cooper Clubman, Cooper S Clubman)

R56 (Cooper, Cooper S)

Vehicles produced from February 28, 2010 through May 4, 2012

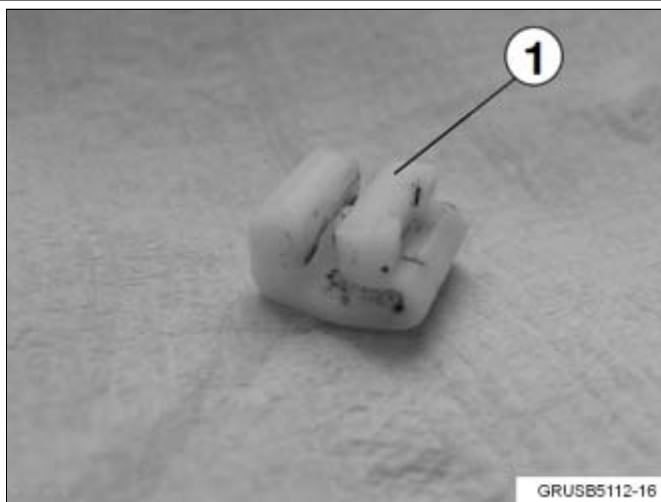
The front side windows can make a squeaking noise when operated.

Confirm the noise is coming from the front window regulator, and remove the regulator using Repair Instruction 51 33 000.

1. Locate the nylon guide clips (1) on the window regulator, and replace the clips using the following steps.
