Service Action: Replace Power Steering Pump Belt Pulley

F10 (5 Series 535d)

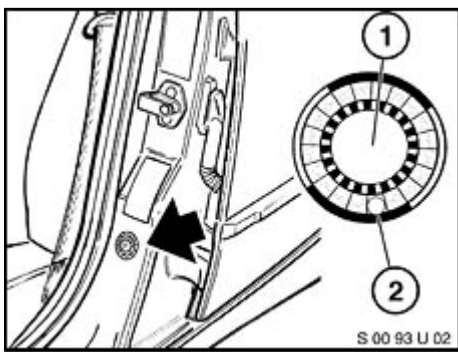
<p>This Service Action has been assigned code number 682. After the vehicle has been checked and/or corrected, obtain a label (SD 92-439) and:</p> <p>A. Emboss your BMW center warranty number in the middle of the label (1);</p>
--	--

- B. Punch out code number **682** (2), printed on the label; and
- C. Affix the label to the B-pillar as shown.
