This Service Information bulletin supersedes SI B33 03 14 **dated April 2014.**

**NEW** **Service Action/Delivery Stop: Rear Shock Absorber Guide Support**

F15 (X5)

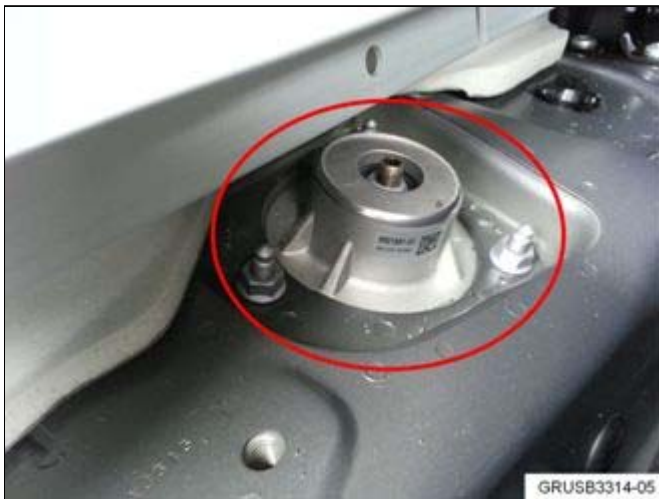
Check the parts label on the guide support.

**NOTE:** The left side of the luggage compartment is shown. It may be necessary to use an inspection mirror to identify the parts label on the right side guide support.

If the incorrect guide support is installed, replace it per Repair Instruction 33 52 161. See the attachment REP3352161.

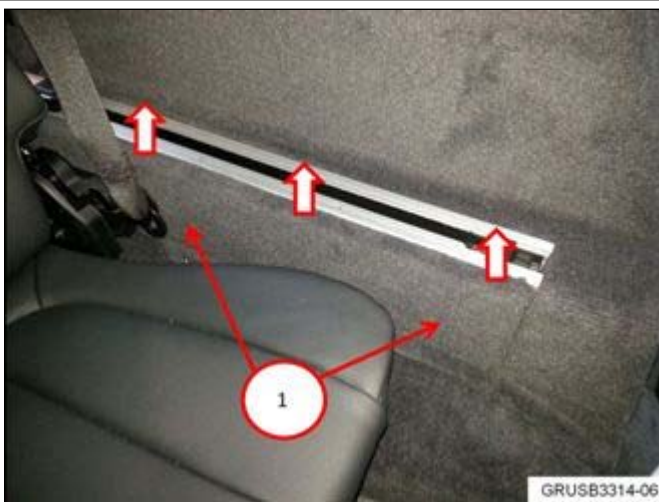
Fold out the third seat row to gain access to the bottom left and right trim panel (1).

Detach the trim panel (1) from the retainers towards the top.

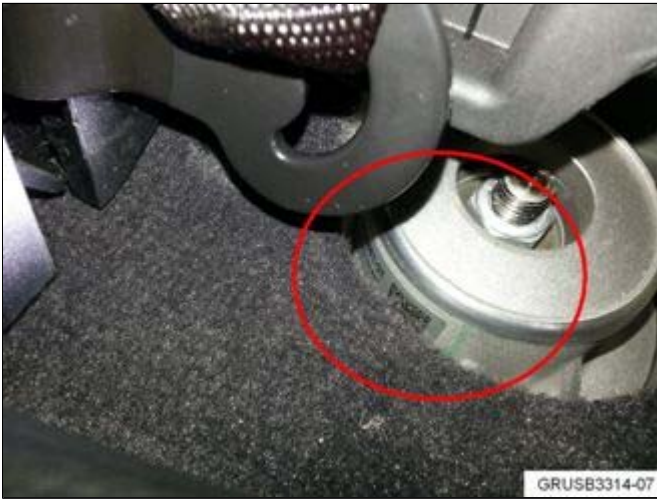
Check the parts label on the guide support.

**NOTE:** The left side of the luggage

compartment is shown. It may be necessary to use an inspection mirror to identify the parts label on the right side guide support.

If the incorrect guide support is installed, replace it per Repair Instruction 33 52 161.

See the attachment REP3352161.
