This Service Information bulletin supersedes SI B51 05 14 **dated February 2014.**

**Service Action: Remove and Discard Water Drain Plugs from E-Box**

F30 (3 Series)

Produced from October 2011 to January 2014

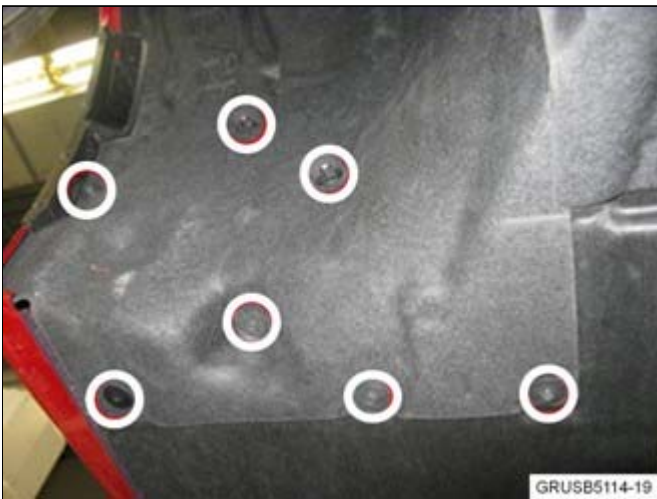
**Note:** The picture is of the front passenger's side wheel house trim.

The wheel is removed in the photo for clarity.

2. Remove the seven fasteners as shown.

**Do not** remove the wheel.

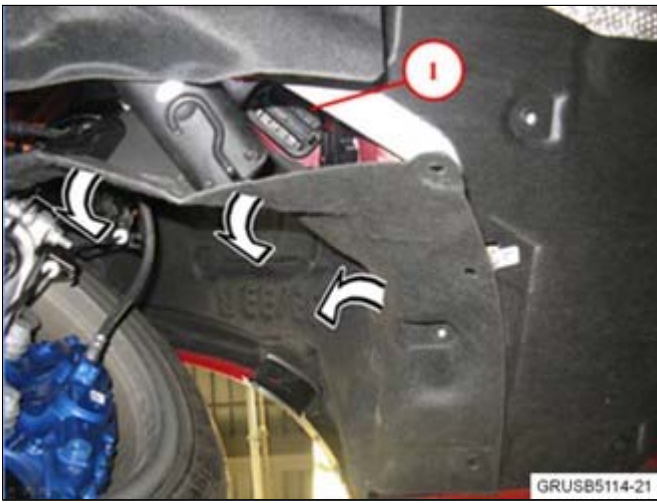
Water leaks into the cabin due to clogged drain plugs in the E-boxes.

The drain plug slots are too small and clog.

E-box drain plug (1) from underneath the vehicle.
