### Automatic Trunk Lift Operation Creates AM Radio Static

F34 (3 Series Gran Turismo)

Produced from January 31, 2013 to June 19, 2014

With option 0316 (automatic trunk lift)

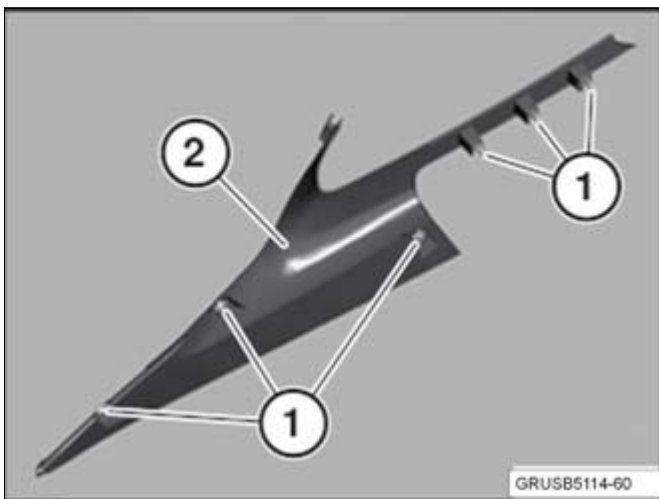
3. The clips (1) on the trim panel (2) must not be damaged or missing.

If necessary, replace any faulty clips (1).

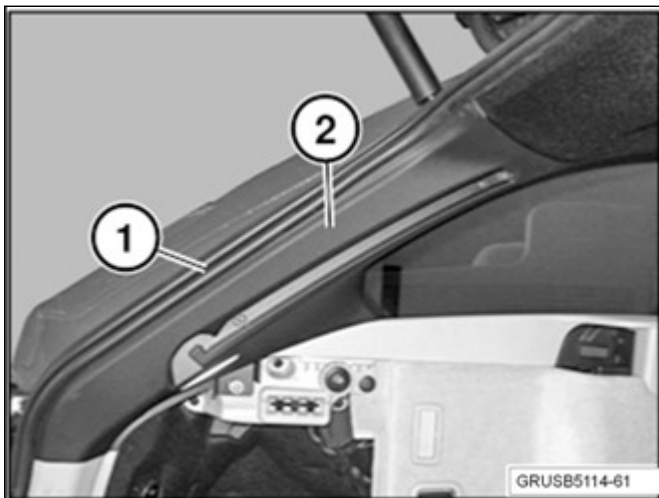
4. The lip of the edge protection (1) in the area of the trim panel (2) must not be trapped. Feed out if necessary.

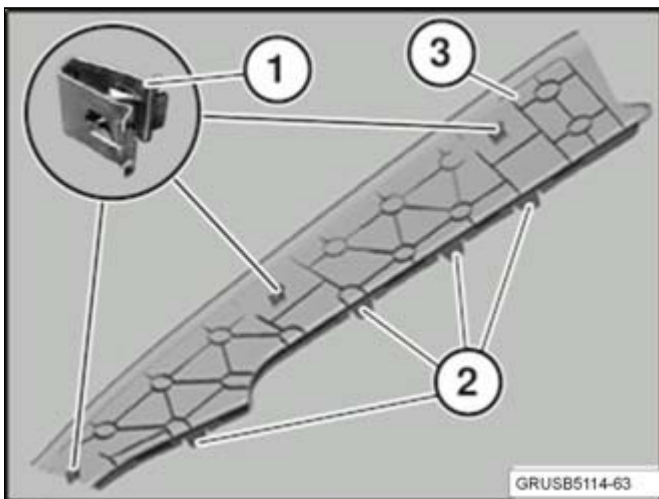
6. The clamps (1) and latch mechanisms (2) of the cover (3) must not be damaged or missing.

If necessary, replace the retainers (1).

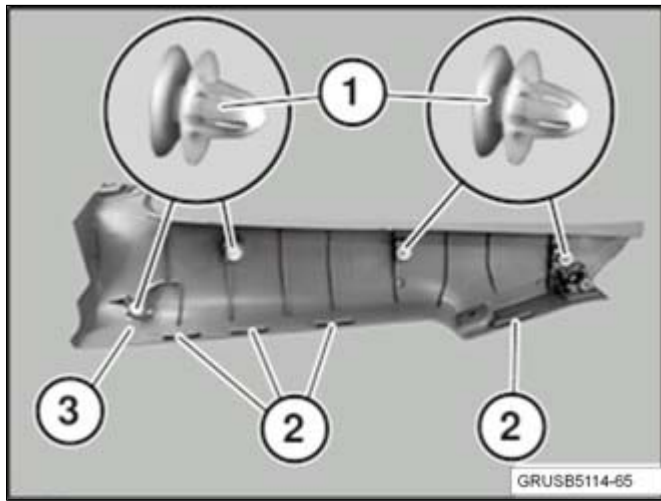
8. The clips (1) and latch mechanisms (2) on the cover (3) must not be damaged or missing.

If necessary, replace the clips (1).

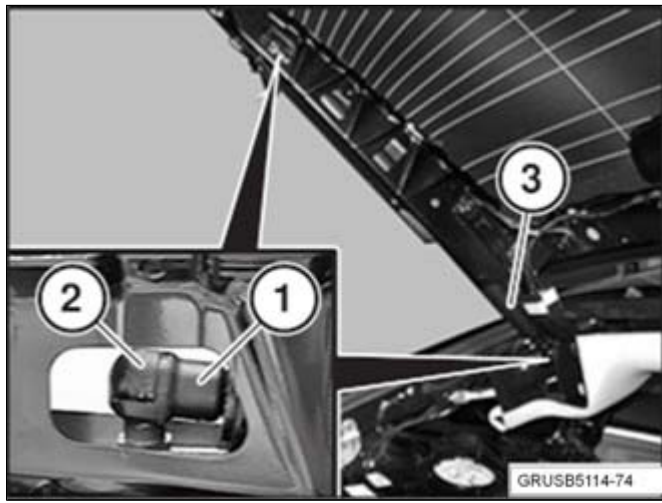
Automatic lift spindle drive motor

Support the trunk in the fully opened position with the suitable apparatus.

Disassemble the ball socket (1) with the clamp (2).

Feed out the spindle drive (3) towards the bottom.
