### Trunk Lid Does Not Open Completely

F30 (3 Series Sedan)

F32 (4 Series Coupe)

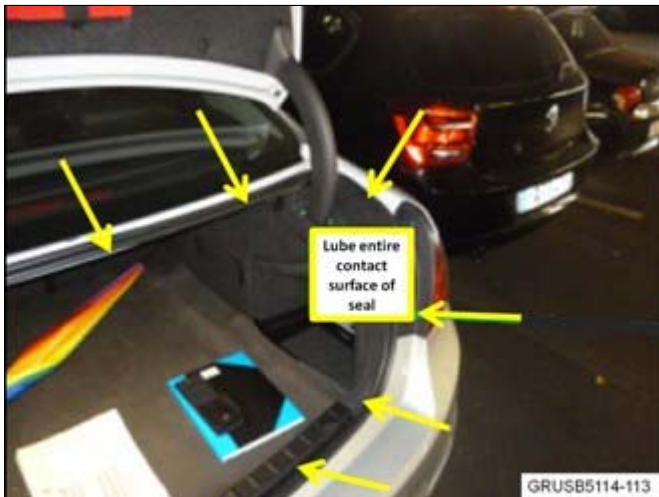
- A dry trunk lid seal causes the trunk lid to stick.
- F30 and F32 only: A trunk return spring that is not installed correctly may not open the trunk lid fully.

1. Open the trunk and clean the entire rubber seal surface that contacts the trunk lid.
2. Apply Carbaflow lubricant to the entire surface of the rubber seal that contacts the trunk lid.

Note: The seal must be completely dry before applying the lubricant.
