**SUBJECT****Panoramic Sunroof Does Not Open or Close****MODEL**

F15 (X5)

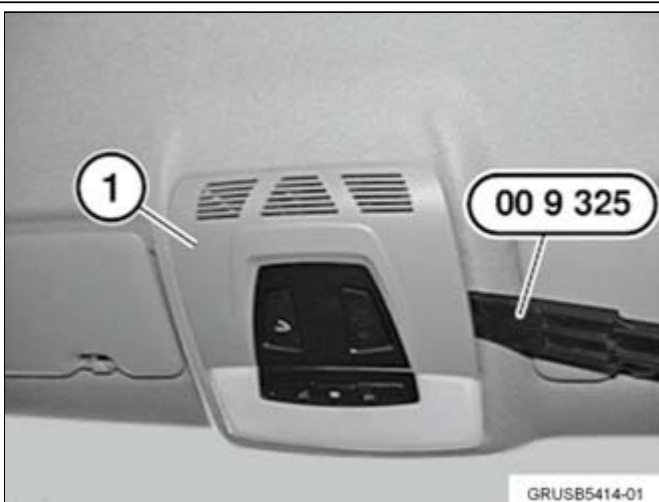
3. Remove the FZD (front roof switch cluster).
4. Using special tool 00 9 325, carefully unclip the switch cover (1).

Ensure the cover (1) is correctly aligned (seated).

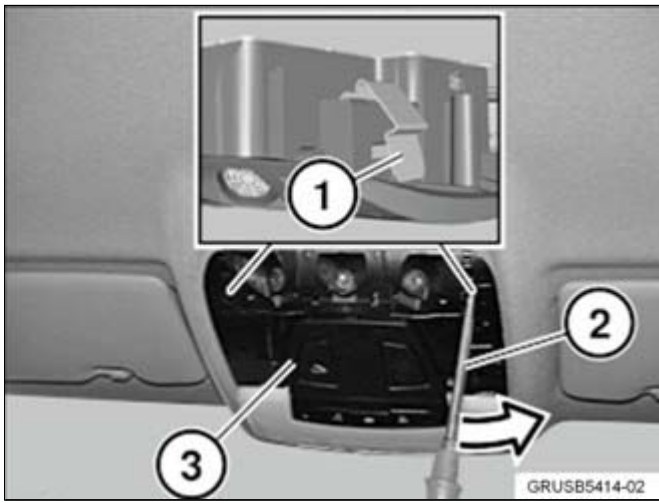
5. Unlock the left and right retaining clips (1) with a screw driver (2), in the direction of the arrow.
6. Remove the switch cluster (3).

Retaining clips (1) must not be damaged.

Ensure the roof switch cluster (3) is correctly fitted.

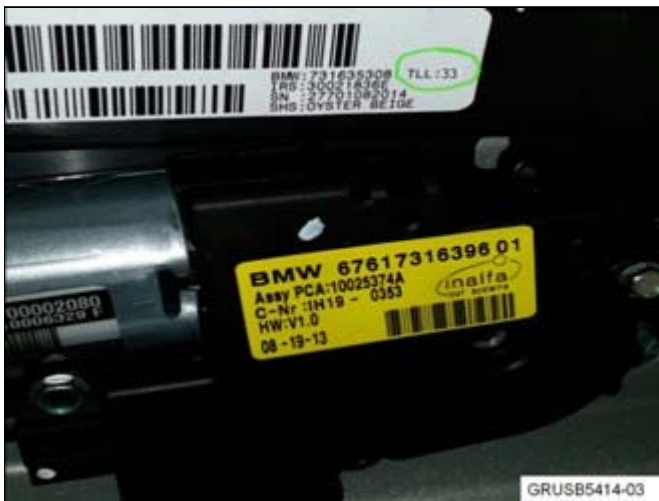
8. This picture shows the TLL number circled in green.
9. If the TLL number ranges from 30 to 38, the complete sunroof cassette must be replaced.
10. Refer to Repair Instruction 54 13 080, "Removing and installing complete glass slide/tilt sunroof."
11. If the TLL number falls outside the range of 30 to 38, this SI no longer applies. The technician must continue with his or her diagnosis using ISTA.
12. Retest the sunroof functionality.

The complete sunroof cassette must be replaced.
