**SUBJECT****Sunroof Does Not Close****MODEL**

F06 (6 Series Gran Coupe)

F13 (6 Series Coupe)

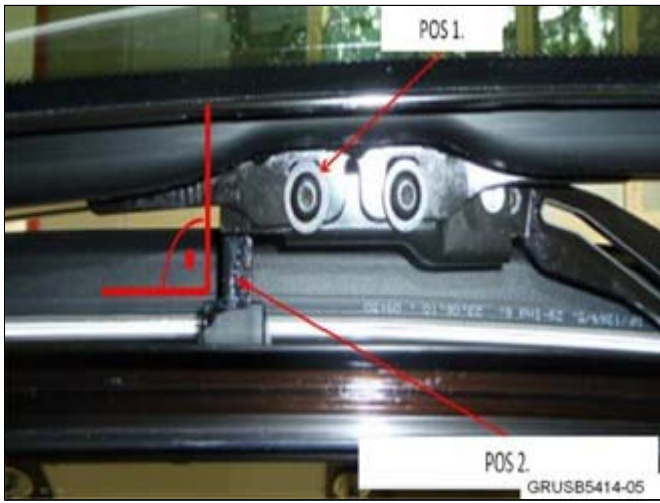
The sunroof seal expands when exposed to the sun and becomes relaxed. This causes the sunroof glass panel to go into “anti-trap” mode during the closing process.

| | <ol style="list-style-type: none"> <li>4. During installation of the glass sunroof per Repair Instruction <b>54 10 100</b>, “Removing and installing glass tilt sunroof cover,” the following must be performed.</li> <li>5. When securing the glass sunroof to the mechanism, first secure the front screw on each side (position 1), and then secure the second screw.</li> </ol> |

6. With the glass sunroof panel in the lifted position, check the position of the glass sunroof guide (position 2). This should be positioned as shown. Correct as needed.
