This Service Information bulletin supersedes SI B54 03 14 **dated May 2014.**

Service Action: Wiring Harness Sensor Rear Module

F33 (4 Series Convertible)

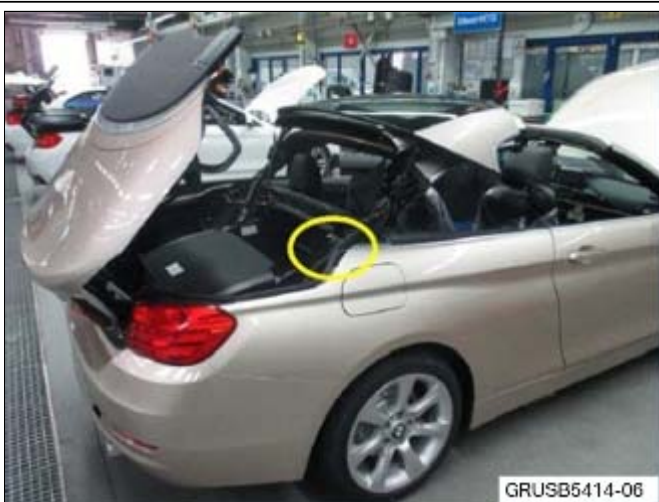
Open the convertible top rear module as shown. The area to be worked on is highlighted by the yellow circle.

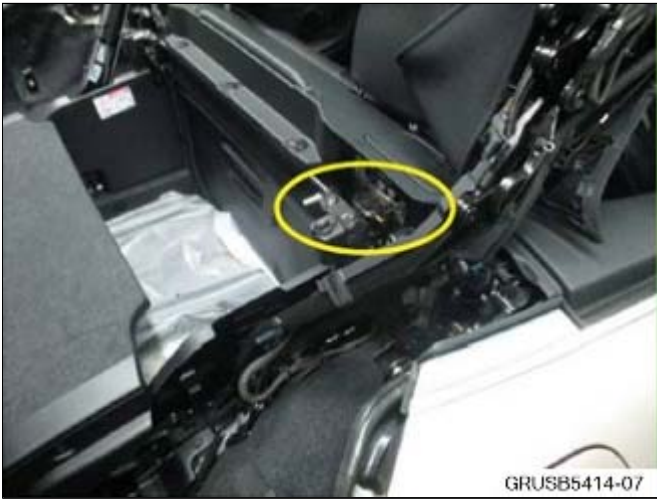
A closer view of the area that will need to be inspected is highlighted in yellow.

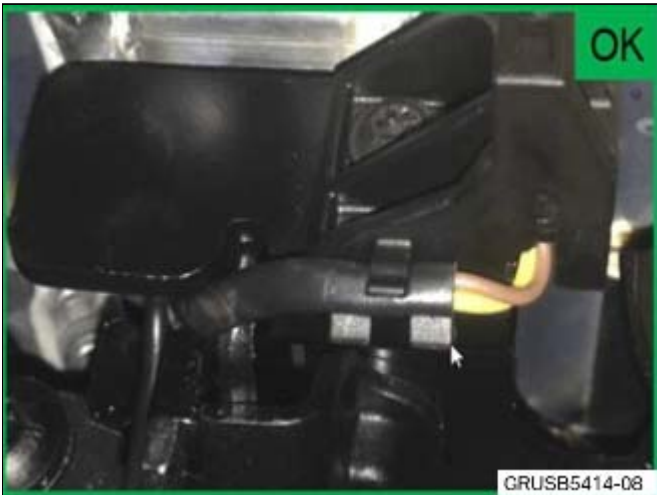
- Inspect the wiring harness. If it is fitted correctly and routed under the base plate as shown, no further action is required.
- If the wiring is not fitted correctly as shown in the picture, proceed to the next step.

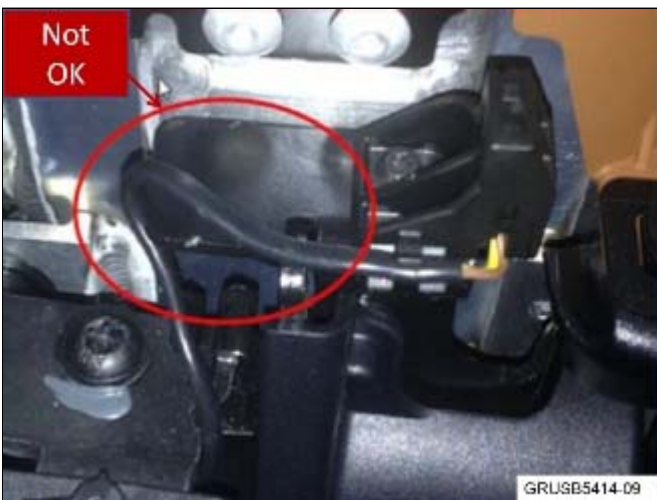
- If the wiring harness is fitted and routed over the base plate as shown, inspect the harness for any damage.
- If damage is found on the harness, proceed to the next step.
- If no damage is found, correct the routing and position the harness under the base plate, as shown in the previous picture.

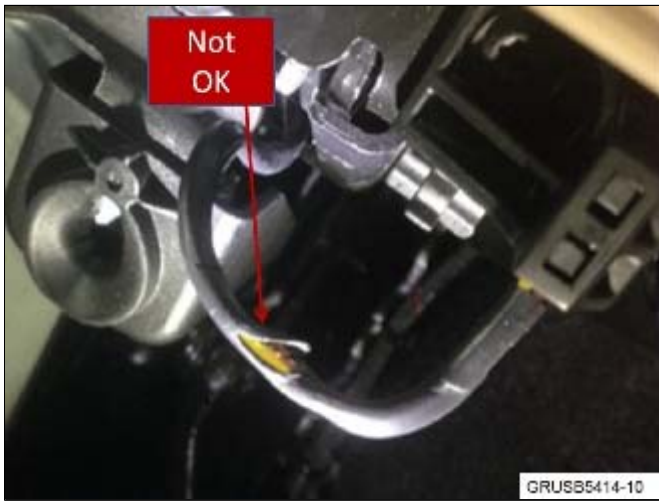
- If damage is found on the harness as shown, the base plate needs to be replaced.

- Proceed to the next step.

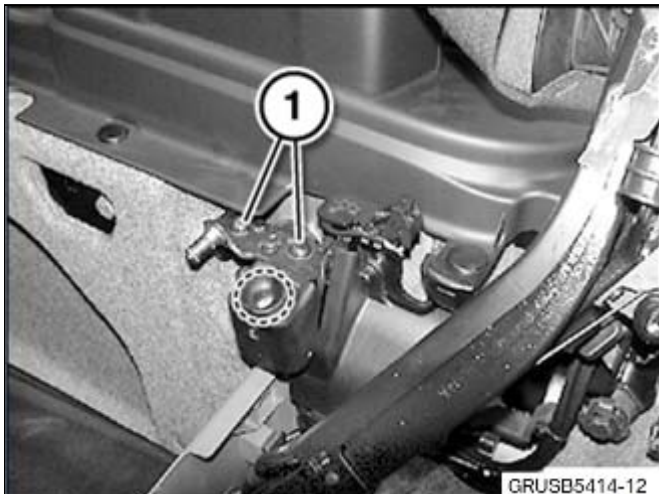
Adjusting the Hall Effect sensor for the roof module

- If there is no signal from the Hall Effect sensor, make the following adjustments.

- Loosely tighten the mounting screws on the holder (1). (It should still be possible to slide the holder to center it.)
- Stow the roof module.
- The optimum position of the holder is determined when the top is closed and the locating pins align into the lock.

- Open the top and tighten the mounting screws.

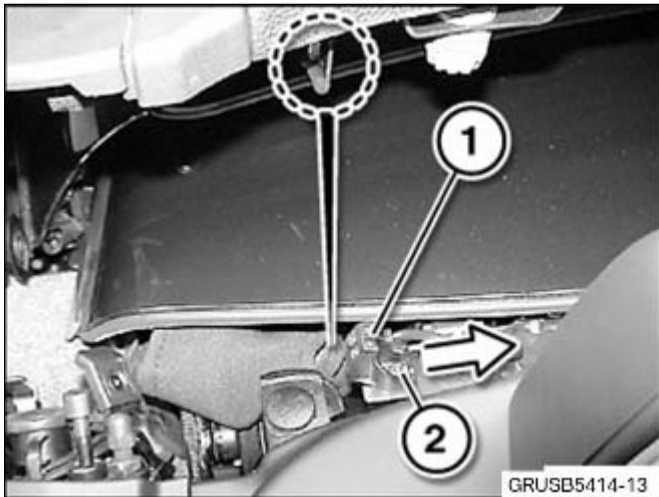
Adjusting the Hall Effect sensor for the soft top compartment lid

Important!
Risk of damage! The switching plate must not rest on the Hall Effect sensor.

- Loosely tighten the screw (2).
- Pull back the Hall Effect sensor (1).

- Carefully close the soft top compartment lid.

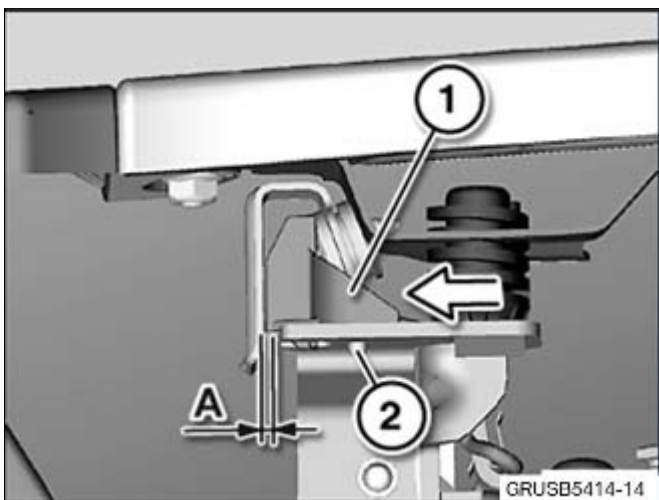
(A) = .04 mm

- Adjust the Hall Effect sensor (1) in relation to the switching plate.

- Tighten the screw (2).
- Check the function of the Hall Effect sensor.
- If necessary, reduce the distance between the Hall Effect sensor and the switching plate.
