This Service Information bulletin supersedes SI B54 04 14 **dated April 2014**.

**NEW** Service Action: Wiring Harness Sensor Rear Module

E89 (Z4)

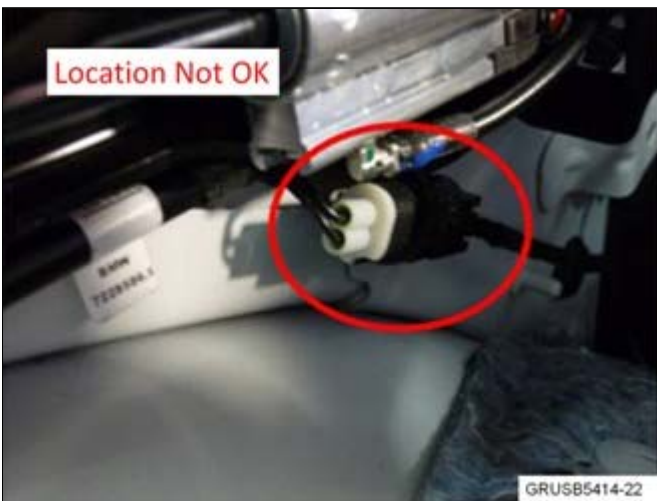
14. This picture shows the sensor connector for the "Rear module closed" sensor incorrectly positioned.
15. Remove the cable tie holding the connector in place.
16. Inspect the sensor wiring harness for damage. If there is no damage, relocate the connector to the position shown in the next picture below.
