Cleaning Excess Butyl from RHT Roof Shells

E93 (3 Series Convertible)

NEW F33 (4 Series Convertible)

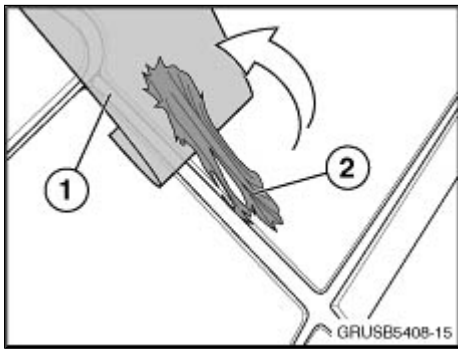
Particularly at high ambient temperatures, if excess butyl is present, it may start to seep out from between the seal and the roof shell.

Excess butyl applied to the roof shell during assembly

<p style="text-align: right; font-size: small;">GRUSB5408-13</p>	<ol style="list-style-type: none"> 1. Use a nylon wedge (1) to press the excess butyl (2) out from under the seal. The excess butyl should be pulled up onto the roof shell as shown.
<p style="text-align: right; font-size: small;">GRUSB5408-14</p>	<ol style="list-style-type: none"> 2. Lay any commercially available plastic tape (1) over the butyl previously pressed out. Press down on the butyl with the nylon wedge (2).
