This Service Information bulletin supersedes SI B63 10 13 **dated January 2014.**

One or Both Outside Mirror Turn Signals Do Not Operate

F15

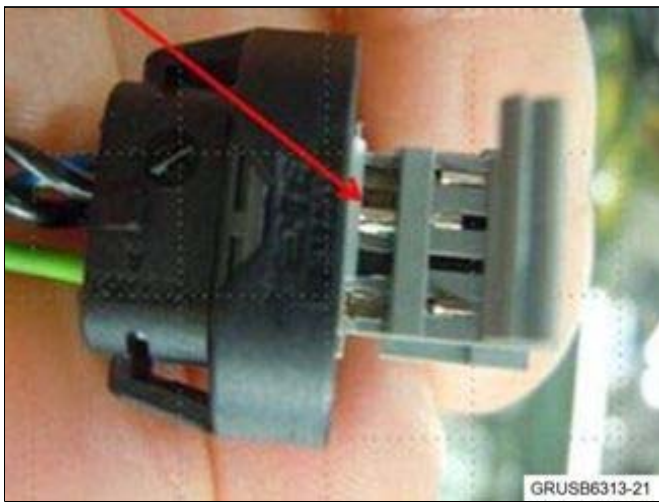
The outside mirror light assembly has a pin pushed back and makes a bad contact.

1. Inspect the connector between the turn signal light and mirror wiring harness. Look for any loose wires or pins pushed back as shown in the picture.

Reinstall the loose pin and make sure it is securely in place.

Check the function and operation of the turn signal.

If no trouble can be found with the pins and the problem is still present, replace the outside mirror turn signal light assembly in the mirror (Procedure Step #2).
